Asbestos Management Survey

Billesley Lane Allotment (Leased), B13 9RL

Report No	D-07818	**Report Issue Date**	23 June 2022
Client Name & Address	Property Services Inclusive Growth Directorate 10 Woodcock Street Birmingham B7 4BG	**Site Address**	Billesley Lane Allotment (Leased), Brick Stores Building , Southlands Road, Birmingham, B13 9RL
Order Placed By	[redacted]	**Instruction Date**	21 February 2022
Order Number	[redacted]	**Project Reference**	[redacted]
Survey Date(s)	15 March 2022	**Lead Surveyor**	[redacted]

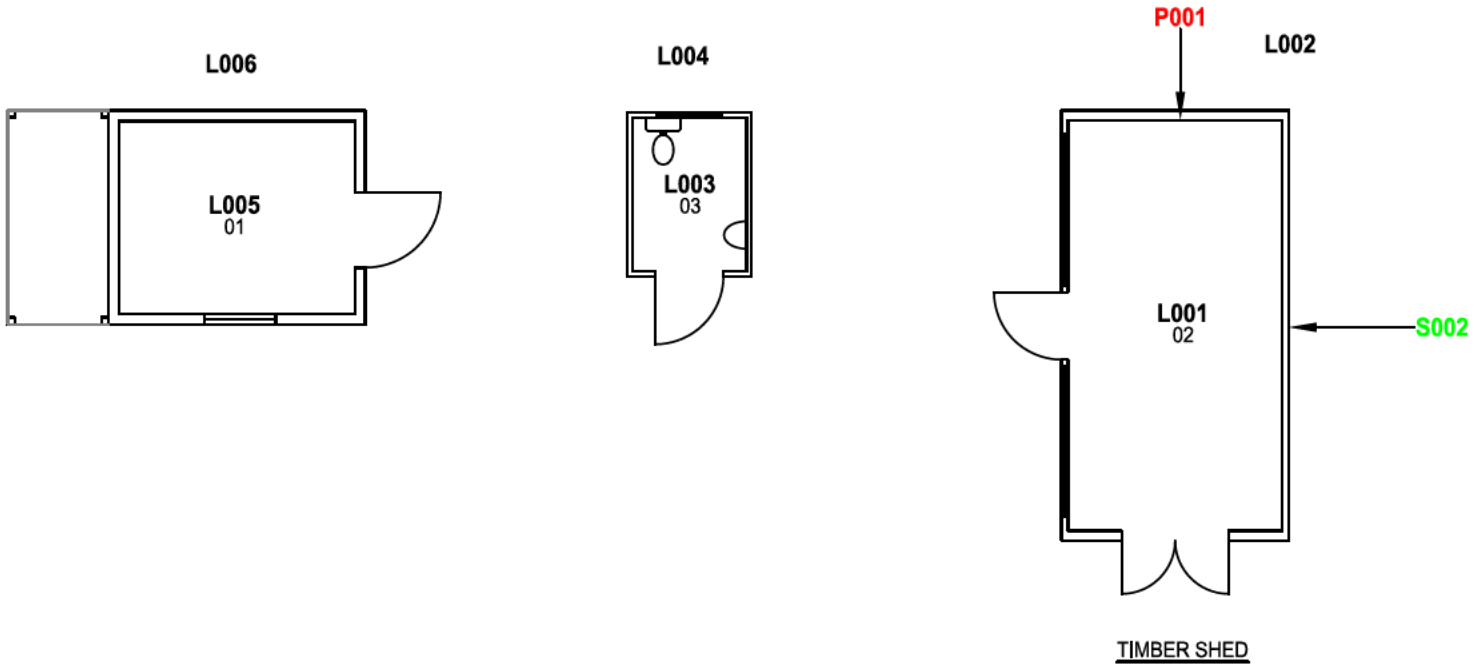
Job No: D - 07818
Drawing No: D - 07818 - 1

Building	Location / Room	Description	Notes
Timber Shed	Floor - 0 001 - Store 02	Within Heater.	Presumed due to no physical access.
