Asbestos Management Survey

Brownfield Road Allotments, B34 7HS

Report No	D-07824	**Report Issue Date**	16 March 2023
Client Name & Address	Property Services Place, Prosperity & Sustainability 10 Woodcock Street Birmingham B7 4BG	**Site Address**	Brownfield Road Allotments, Brownfield Road, Birmingham, B34 7HS
Order Placed By	[redacted]	**Instruction Date**	21 February 2022
Order Number	[redacted]	**Project Reference**	[redacted]
Survey Date(s)	Between 01/03/2022 and 24/03/2022	**Lead Surveyor**	[redacted]

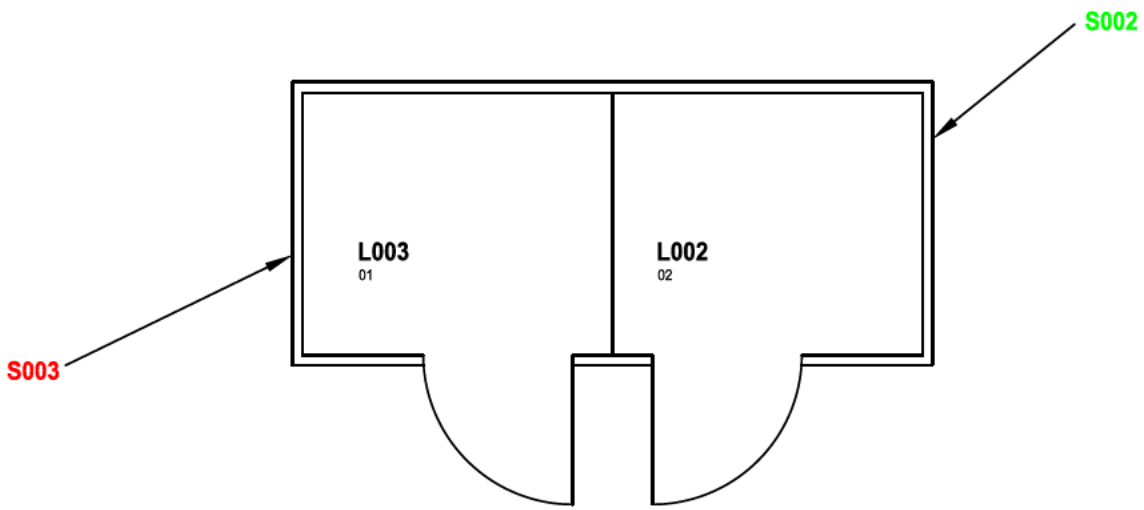
BLOCK 2

Description Damp Proof Course.

Score
Asbestos Type	CHRYSOTILE	1
Product Type	Bitumen Products	1
Extent of Damage	Good Condition	0
Surface Treatment	Composite, reinforced or bonded	0
Estimated Amount	20 L/M	
Accessibility	Usually Inaccessible	
Risk Score		2

Recommendation	Manage & Re-inspect
Notes
