Asbestos Management Survey

Burney Lane Allotments, B8 2AH

Report No	D-07825	**Report Issue Date**	8 July 2022
Client Name & Address	Property Services Inclusive Growth Directorate 10 Woodcock Street Birmingham B7 4BG	**Site Address**	Burney Lane Allotments, Concrete Stores, Cotterills Lane, Birmingham, B8 2AH
Order Placed By	[redacted]	**Instruction Date**	21 February 2022
Order Number	[redacted]	**Project Reference**	[redacted]
Survey Date(s)	23 March 2022	**Lead Surveyor**	[redacted]

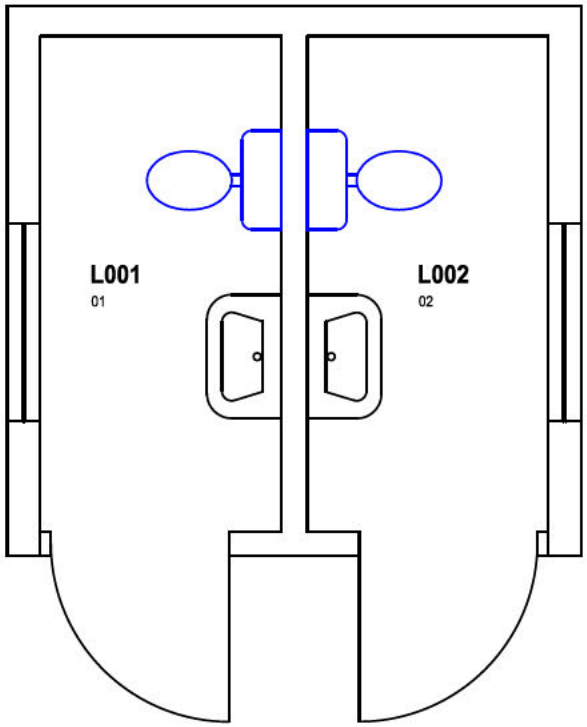
BLOCK A

Score
Asbestos Type	NO ASBESTOS DETECTED	-
Product Type	Felt	-
Extent of Damage	Medium Damage	-
Surface Treatment	Composite, reinforced or bonded	-
Estimated Amount	15 m²	
Accessibility	Usually Inaccessible	
Risk Score		0

Score
Asbestos Type	NO ASBESTOS DETECTED	-
Product Type	Putty	-
Extent of Damage	Low Damage	-
Surface Treatment	Composite, reinforced or bonded	-
Estimated Amount	15 L/M	
Accessibility	Occasional Disturbance	
Risk Score		0

L003 - EXTERIOR
S001
S002

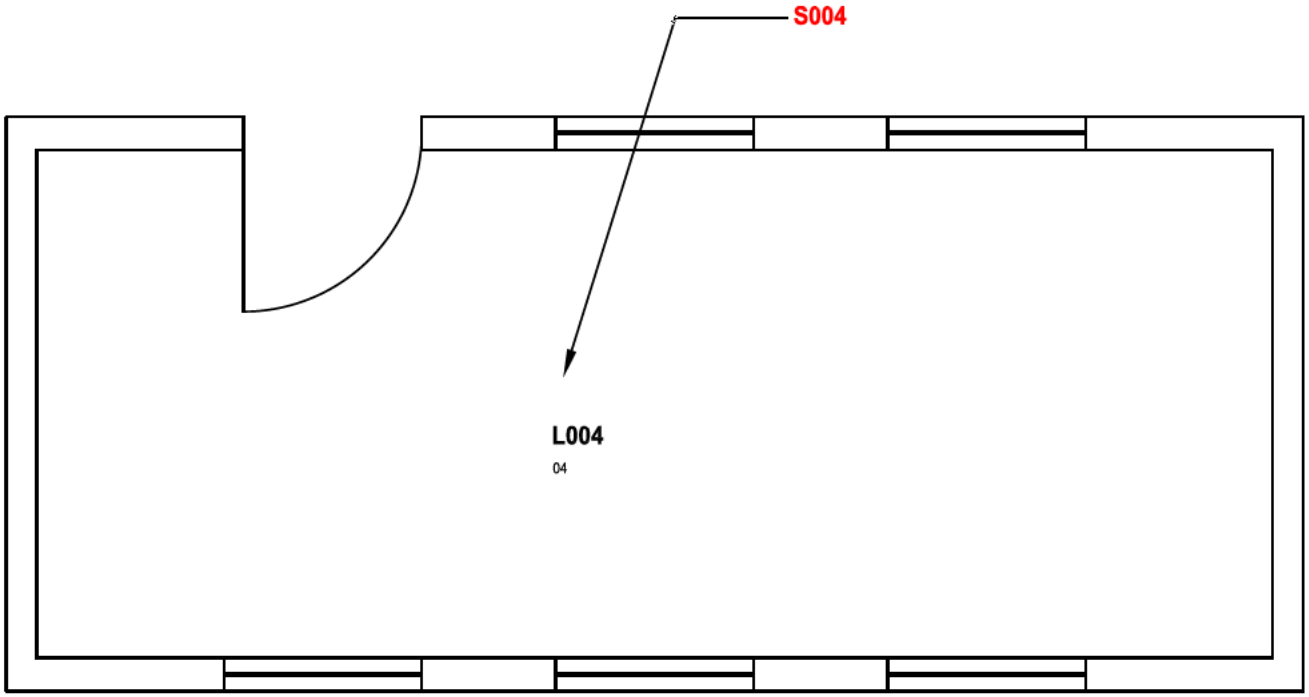
BLOCK C

Building	Floor	Location/ Room	Position	Item	Sample No.	Inspection Ref	Risk Score
Block C	0	004 - Common room 04	Roof	Cement Panels	S004	719081	4

Score
Asbestos Type	CHRYSOTILE	1
Product Type	Cement Panels	1
Extent of Damage	Low Damage	1
Surface Treatment	Unsealed cement / Enclosed lagging or spray / Encapsulated board	1
Estimated Amount	50 m²	
Accessibility	Usually Inaccessible	
Risk Score		4

Recommendation	Manage & Re-inspect
Notes

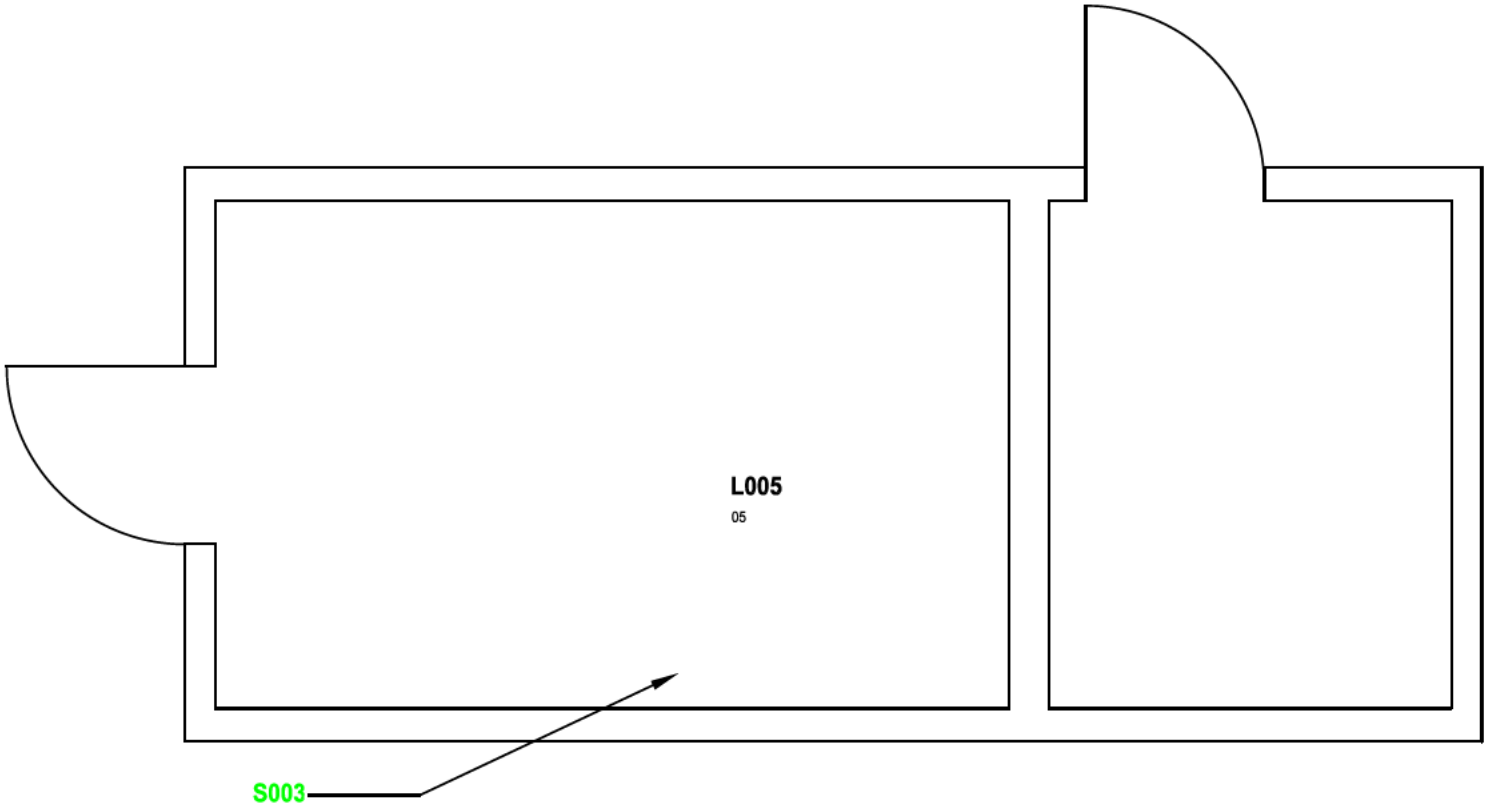
BLOCK D

Score
Asbestos Type	NO ASBESTOS DETECTED	-
Product Type	Putty	-
Extent of Damage	Low Damage	-
Surface Treatment	Composite, reinforced or bonded	-
Estimated Amount	30 L/M	
Accessibility	Occasional Disturbance	
Risk Score		0
