Asbestos Management Survey

Clunbury Road Allotments, B31 3SZ

Report No	D-07827	**Report Issue Date**	7 July 2022
Client Name & Address	Property Services Inclusive Growth Directorate 10 Woodcock Street Birmingham B7 4BG	**Site Address**	Clunbury Road Allotments, Concrete Shed, Clunbury Road, Birmingham, B31 3SZ
Order Placed By	[redacted]	**Instruction Date**	21 February 2022
Order Number	[redacted]	**Project Reference**	[redacted]
Survey Date(s)	24 March 2022	**Lead Surveyor**	[redacted]

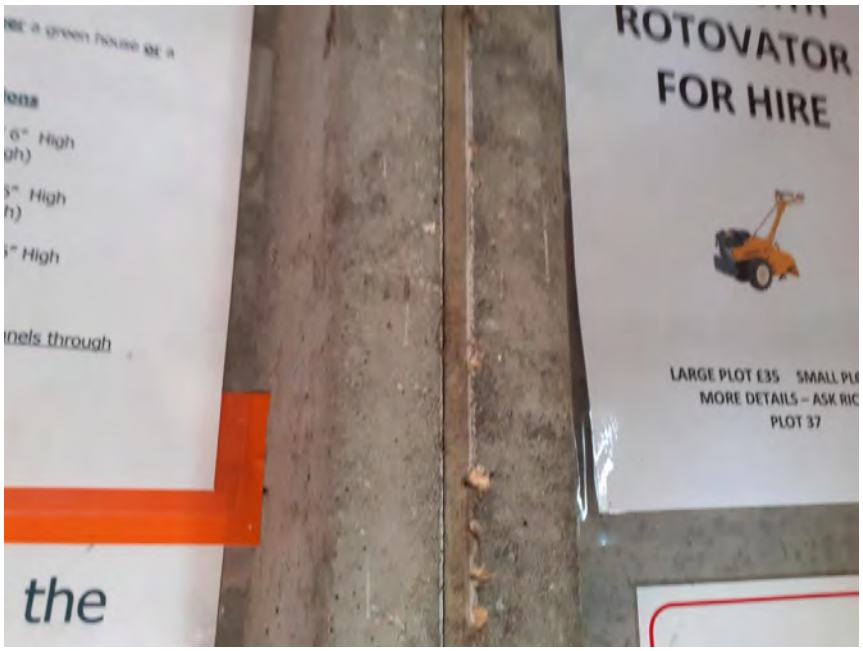
Surveyor	[redacted]		**Building**	Block A
Survey Type	Management		**Floor**	0
Survey Date	24/03/2022		**Location/ Room**	001 - Shed 01
Next Inspection	24/03/2023		**Sample No**	S001
Level of Identification	Sample Analysed		**Inspection Ref**	719519

Description Walls .

Score
Asbestos Type	NO ASBESTOS DETECTED	-
Product Type	Putty	-
Extent of Damage	Good Condition	-
Surface Treatment	Composite, reinforced or bonded	-
Estimated Amount	35 L/M	
Accessibility	Occasional Disturbance	
Risk Score		0

Recommendation	No Recommendation Required
Notes
