Asbestos Management Survey

Court Oak Road Allotments, B32 2EA

Report No	D-07831	**Report Issue Date**	10 October 2022
Client Name & Address	Property Services Inclusive Growth Directorate 10 Woodcock Street Birmingham B7 4BG	**Site Address**	Court Oak Road Allotments, Court Oak Road, Quinton, Birmingham, B32 2EA
Order Placed By	[redacted]	**Instruction Date**	21 February 2022
Order Number	[redacted]	**Project Reference**	[redacted]
Survey Date(s)	16 March 2022	**Lead Surveyor**	[redacted]

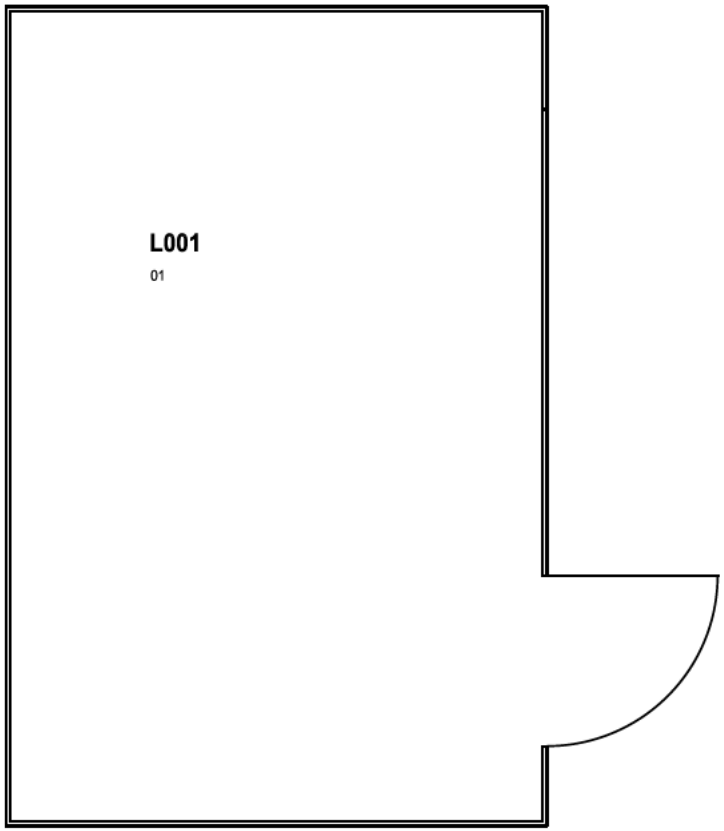
BLOCK A

XXX SAMPLE LOCATION
No ACM Identified

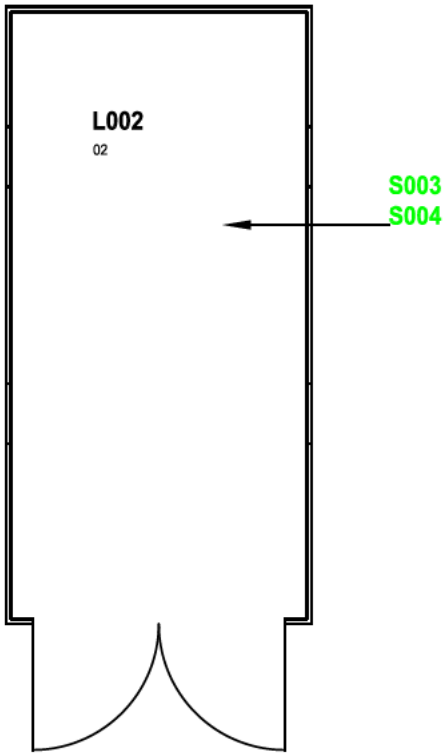
BLOCK B

Surveyor	[redacted]	**Building**	Block B
Survey Type	Management	**Floor**	0
Survey Date	16/03/2022	**Location/ Room**	002 - Shed 02
Next Inspection	16/03/2023	**Sample No**	S003
Level of Identification	Sample Analysed	**Inspection Ref**	715458

Description Roof.

Score
Asbestos Type	NO ASBESTOS DETECTED	-
Product Type	Sprayed Coating	-
Extent of Damage	Low Damage	-
Surface Treatment	Unsealed lagging, sprays and loose fibrous debris	-
Estimated Amount	40 m²	
Accessibility	Usually Inaccessible	
Risk Score		0

Surveyor	[redacted]		**Building**	Block B
Survey Type	Management		**Floor**	0
Survey Date	16/03/2022		**Location/ Room**	002 - Shed 02
Next Inspection	16/03/2023		**Sample No**	S004
Level of Identification	Sample Analysed		**Inspection Ref**	715459

Description Walls.

Score
Asbestos Type	NO ASBESTOS DETECTED	-
Product Type	Putty	-
Extent of Damage	Good Condition	-
Surface Treatment	Composite, reinforced or bonded	-
Estimated Amount	40 L/M	
Accessibility	Occasional Disturbance	
Risk Score		0

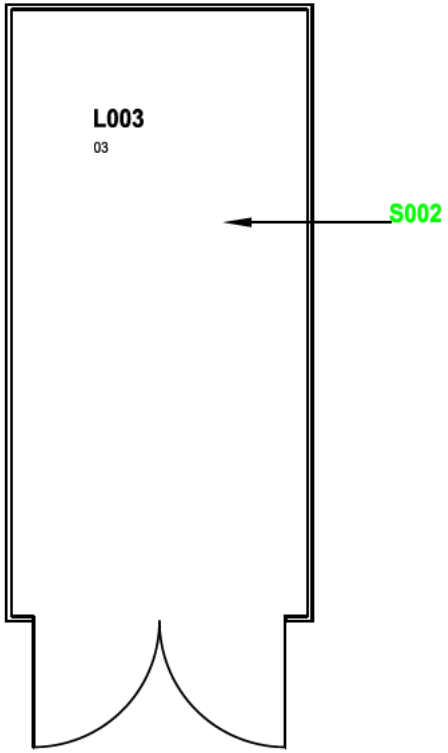
BLOCK C

Surveyor	[redacted]	**Building**	Block C
Survey Type	Management	**Floor**	0
Survey Date	16/03/2022	**Location/ Room**	003 - Shed 03
Next Inspection	16/03/2023	**Sample No**	S002
Level of Identification	Sample Analysed	**Inspection Ref**	715453

Description Walls.

Score
Asbestos Type	NO ASBESTOS DETECTED	-
Product Type	Putty	-
Extent of Damage	Good Condition	-
Surface Treatment	Composite, reinforced or bonded	-
Estimated Amount	30 L/M	
Accessibility	Occasional Disturbance	
Risk Score		0
