Asbestos Management Survey

Hawthorn House Allotments, B20 1NR

Report No	D-07837	**Report Issue Date**	8 July 2022
Client Name & Address	Property Services Inclusive Growth Directorate 10 Woodcock Street Birmingham B7 4BG	**Site Address**	Hawthorn House Allotments, Pavilion, Hamstead Hall Road, Birmingham, B20 1NR
Order Placed By	[redacted]	**Instruction Date**	21 February 2022
Order Number	[redacted]	**Project Reference**	[redacted]
Survey Date(s)	14 March 2022	**Lead Surveyor**	[redacted]

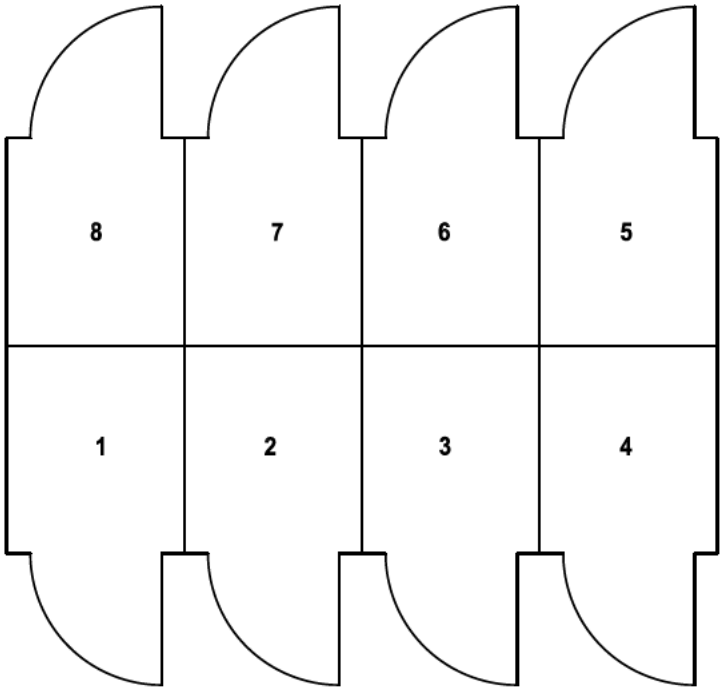
TOOL LOCKERS BLOCK 1

L013 - EXTERIOR
S010

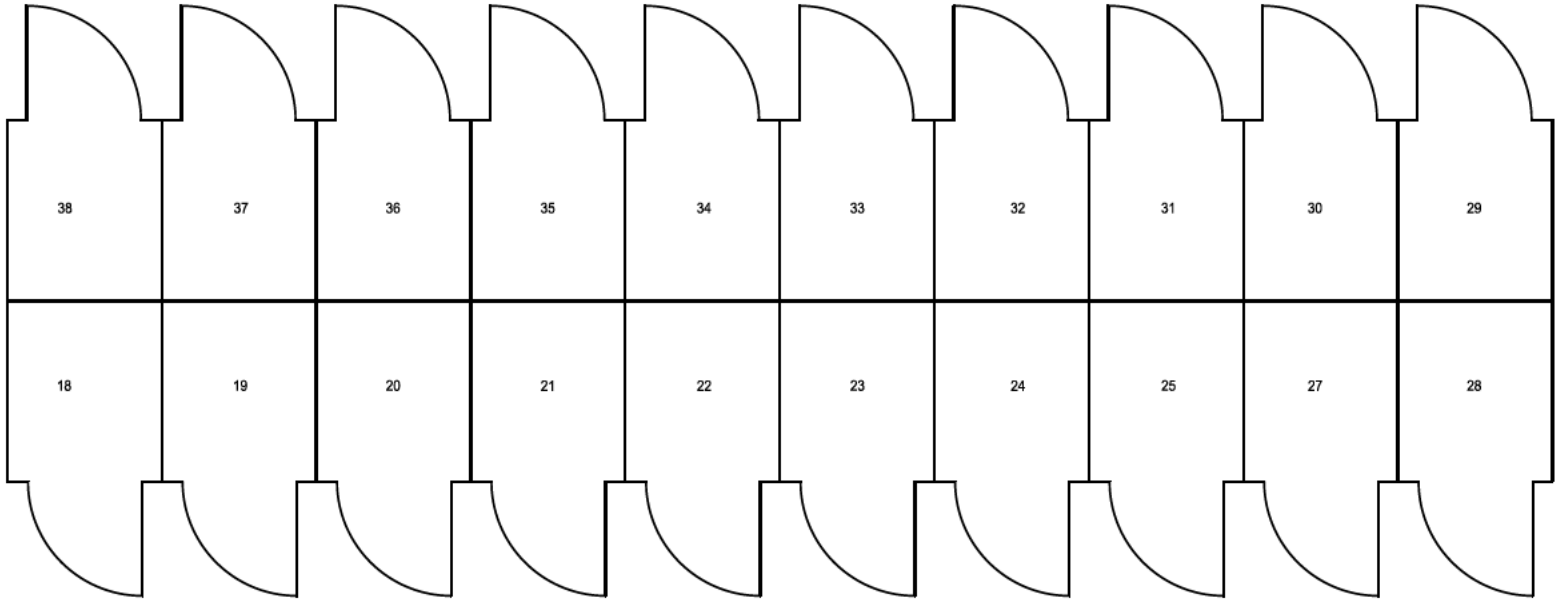
TOOL LOCKERS BLOCK 3

L008
S008
