Asbestos Management Survey

Henlow Road Allotments, B14 5DX

Report No	D-07839	**Report Issue Date**	24 June 2022
Client Name & Address	Property Services Inclusive Growth Directorate 10 Woodcock Street Birmingham B7 4BG	**Site Address**	Henlow Road Allotments, Henlow Road, Birmingham, B14 5DX
Order Placed By	[redacted]	**Instruction Date**	21 February 2022
Order Number	[redacted]	**Project Reference**	[redacted]
Survey Date(s)	17 March 2022	**Lead Surveyor**	[redacted]

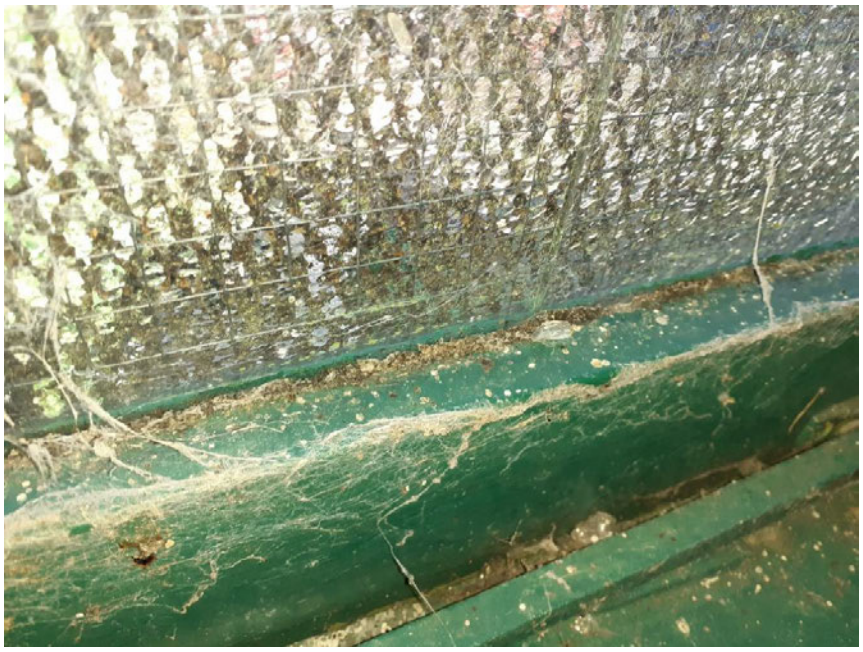
Surveyor	[redacted]		**Building**	C Building
Survey Type	Management		**Floor**	0
Survey Date	17/03/2022		**Location/ Room**	006 - Toilet 03
Next Inspection	17/03/2023		**Sample No**	X003
Level of Identification	Strongly Presumed		**Inspection Ref**	715793

Description Putty Within Window Frame. Visually consistent with Sample 3.

Score
Asbestos Type	NO ASBESTOS DETECTED	-
Product Type	Putty	-
Extent of Damage	Low Damage	-
Surface Treatment	Composite, reinforced or bonded	-
Estimated Amount	1 L/M	
Accessibility	Occasional Disturbance	
Risk Score		0

Recommendation	No Recommendation Required
Notes
