Asbestos Management Survey

Pool Lane Leisure Gardens Allotment, B33 8HG

Report No	D-07842	**Report Issue Date**	20 April 2023
Client Name & Address	Property Services Place, Prosperity & Sustainability 10 Woodcock Street Birmingham B7 4BG	**Site Address**	Pool Lane Leisure Gardens Allotments, Meadway, Stechford and Yardley North, Birmingham, B33 8HG
Order Placed By	[redacted]	**Instruction Date**	21 February 2022
Order Number	[redacted]	**Project Reference**	[redacted]
Survey Date(s)	22 February 2023	**Lead Surveyor**	[redacted]

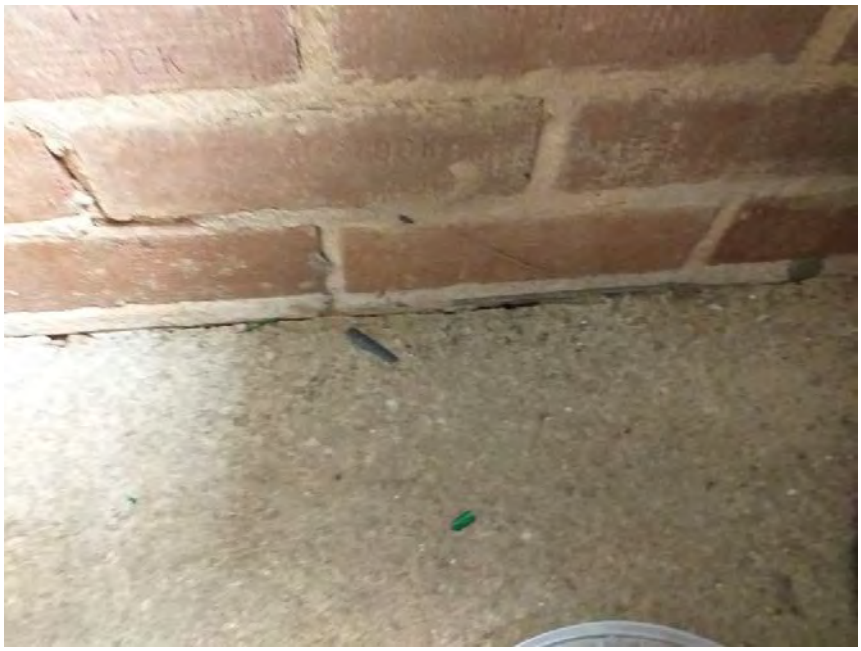
Surveyor	[redacted]	**Building**	Toilet
Survey Type	Management	**Floor**	0
Survey Date	22/02/2023	**Location/ Room**	0001 - Ladies Toilet 01
Next Inspection	22/02/2024	**Sample No**	S002
Level of Identification	Sample Analysed	**Inspection Ref**	817612

Description Damp Proof Course.

Score
Asbestos Type	NO ASBESTOS DETECTED	-
Product Type	Bitumen Products	-
Extent of Damage	Good Condition	-
Surface Treatment	Composite, reinforced or bonded	-
Estimated Amount	Unknown	
Accessibility	Usually Inaccessible	
Risk Score		0

Recommendation	No Recommendation Required
Notes
