Asbestos Management Survey

Gospel Lane Allotments, B27 7AX

Report No	D-07845	**Report Issue Date**	14 March 2023
Client Name & Address	Property Services Place, Prosperity & Sustainability 10 Woodcock Street Birmingham B7 4BG	**Site Address**	Gospel Lane Allotments, Gospel Lane, Birmingham, B27 7AX
Order Placed By	[redacted]	**Instruction Date**	21 February 2022
Order Number	[redacted]	**Project Reference**	[redacted]
Survey Date(s)	on 04/04/2022	**Lead Surveyor**	[redacted]

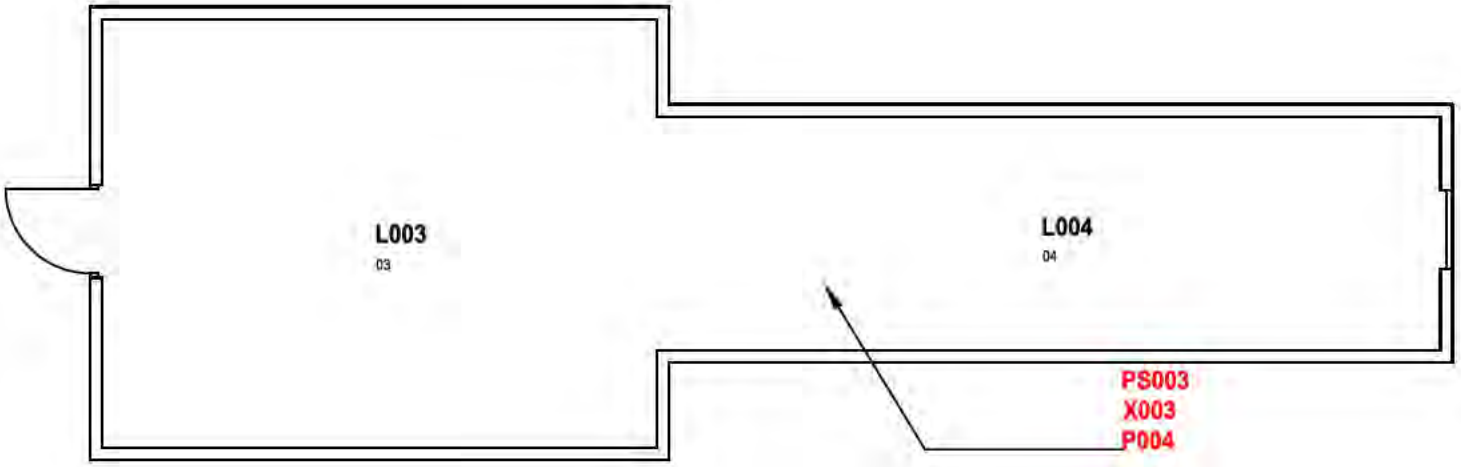
BLOCK C

Surveyor	[redacted]		**Building**	Block C
Survey Type	Management		**Floor**	0
Survey Date	04/04/2022		**Location/ Room**	004 - Store 04
Next Inspection	04/04/2023		**Sample No**	P004
Level of Identification	Presumed		**Inspection Ref**	721316

Description Electrics (older items).

Recommendation	Inspection Required
Notes	Live unable to inspect.

Surveyor	[redacted]	**Building**	Block C
Survey Type	Management	**Floor**	0
Survey Date	04/04/2022	**Location/ Room**	004 - Store 04
Next Inspection	04/04/2023	**Sample No**	PS003
Level of Identification	Previously Sampled	**Inspection Ref**	721311

Description Roof.

Score
Asbestos Type	CHRYSOTILE	1
Product Type	Cement Panels	1
Extent of Damage	High Damage	3
Surface Treatment	Unsealed cement / Enclosed lagging or spray / Encapsulated board	1
Estimated Amount	60 m²	
Accessibility	Occasional Disturbance	
Risk Score		6

Surveyor	[redacted]	**Building**	Block C
Survey Type	Management	**Floor**	0
Survey Date	04/04/2022	**Location/ Room**	004 - Store 04
Next Inspection	04/04/2023	**Sample No**	X003
Level of Identification	Strongly Presumed	**Inspection Ref**	721315

Description Floor. Visually consistent with Sample 3.

Score
Asbestos Type	CHRYSOTILE	1
Product Type	Cement Panels	1
Extent of Damage	High Damage	3
Surface Treatment	Unsealed cement / Enclosed lagging or spray / Encapsulated board	1
Estimated Amount	40 m²	
Accessibility	Easily Disturbed	
Risk Score		6

Recommendation	Prohibit Access, Remove and Manage
Notes	Debris from roof present throughout.

Recommendation	Remove and Manage
Notes	Previously Sampled D-07449-001
