Asbestos Management Survey

Kingstanding Allotments, B44 0XE

Report No	D-07847	**Report Issue Date**	11 October 2022
Client Name & Address	Property Services Inclusive Growth Directorate 10 Woodcock Street Birmingham B7 4BG	**Site Address**	Kingstanding Allotments, Edmonton Road, Birmingham, B44 0XE
Order Placed By	[redacted]	**Instruction Date**	21 February 2022
Order Number	[redacted]	**Project Reference**	[redacted]
Survey Date(s)	20 April 2022	**Lead Surveyor**	[redacted]

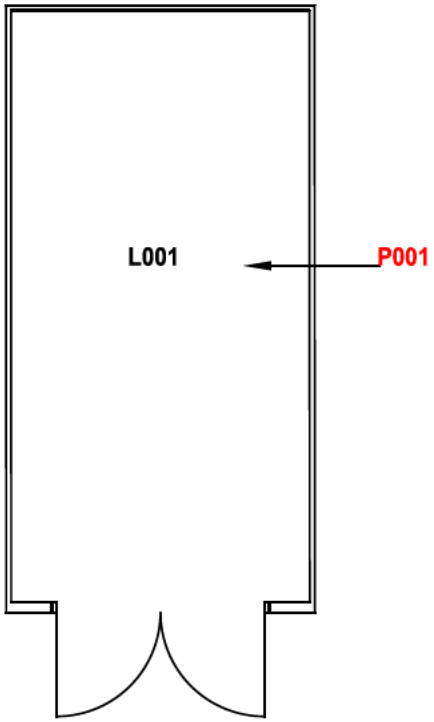
Job No: D - 07847
Drawing No: D - 07847 - 1

Building	Location / Room	Description	Notes
Main building	Floor - 0 001 - Shed 01	No Access.	No access to interior as key holder did not turn up to the arranged appointment with myself and the allotment manager. Shed is no longer in use.
