Asbestos Management Survey

Lime Tree Road Allotments, B8 2XR

Report No	D-07848	**Report Issue Date**	14 September 2022
Client Name & Address	Inclusive Growth - Property Services Inclusive Growth Directorate 10 Woodcock Street Birmingham B7 4BG	**Site Address**	Lime Tree Road Allotments, Lime Tree Road, Washwood Heath, Birmingham, B8 2XR
Order Placed By	[redacted]	**Instruction Date**	21 February 2022
Order Number	[redacted]	**Project Reference**	[redacted]
Survey Date(s)	28 March 2022	**Lead Surveyor**	[redacted]

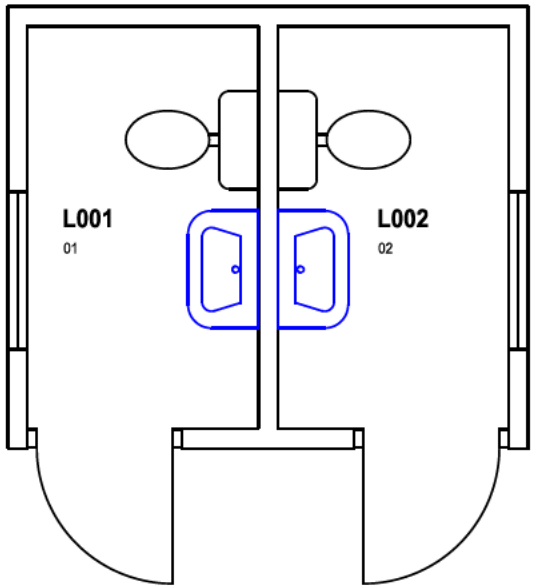
TOILET BLOCK

Description Walls .

Score
Asbestos Type	NO ASBESTOS DETECTED	-
Product Type	Putty	-
Extent of Damage	Low Damage	-
Surface Treatment	Composite, reinforced or bonded	-
Estimated Amount	30 L/M	
Accessibility	Occasional Disturbance	
Risk Score		0

L003 - EXTERIOR
S001

Recommendation	No Recommendation Required
Notes

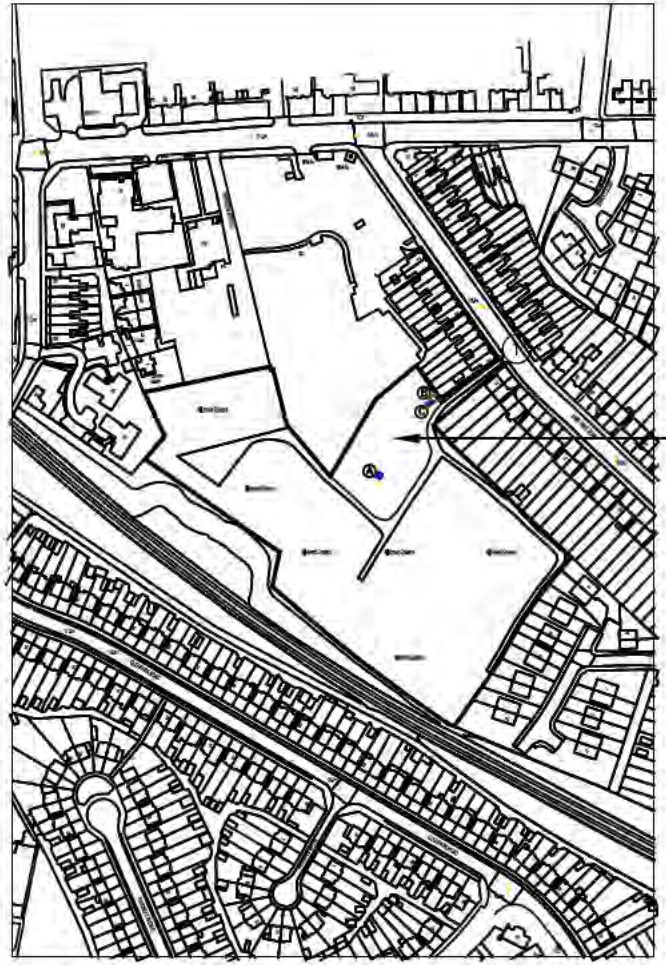
MAIN BUILDING

Building	Floor	Location/ Room	Position	Item	Sample No.	Inspection Ref	Risk Score
Main building	99	004 - Allotment	Floor	Cement Panels	S002	719928	5

Description Floor.

Score
Asbestos Type	CHRYSOTILE	1
Product Type	Cement Panels	1
Extent of Damage	Medium Damage	2
Surface Treatment	Unsealed cement / Enclosed lagging or spray / Encapsulated board	1
Estimated Amount	10 m²	
Accessibility	Occasional Disturbance	
Risk Score		5

Recommendation	Remove and Manage
Notes	Discarded panels near entrance.
