Asbestos Management Survey

Marsh Hill Allotments, B23 7EZ

Report No	D-07851	**Report Issue Date**	10 October 2022
Client Name & Address	Property Services Inclusive Growth Directorate 10 Woodcock Street Birmingham B7 4BG	**Site Address**	Marsh Hill Allotments, Marsh Hill Lane, Birmingham, B23 7EZ
Order Placed By	[redacted]	**Instruction Date**	21 February 2022
Order Number	[redacted]	**Project Reference**	[redacted]
Survey Date(s)	30 March 2022	**Lead Surveyor**	[redacted]

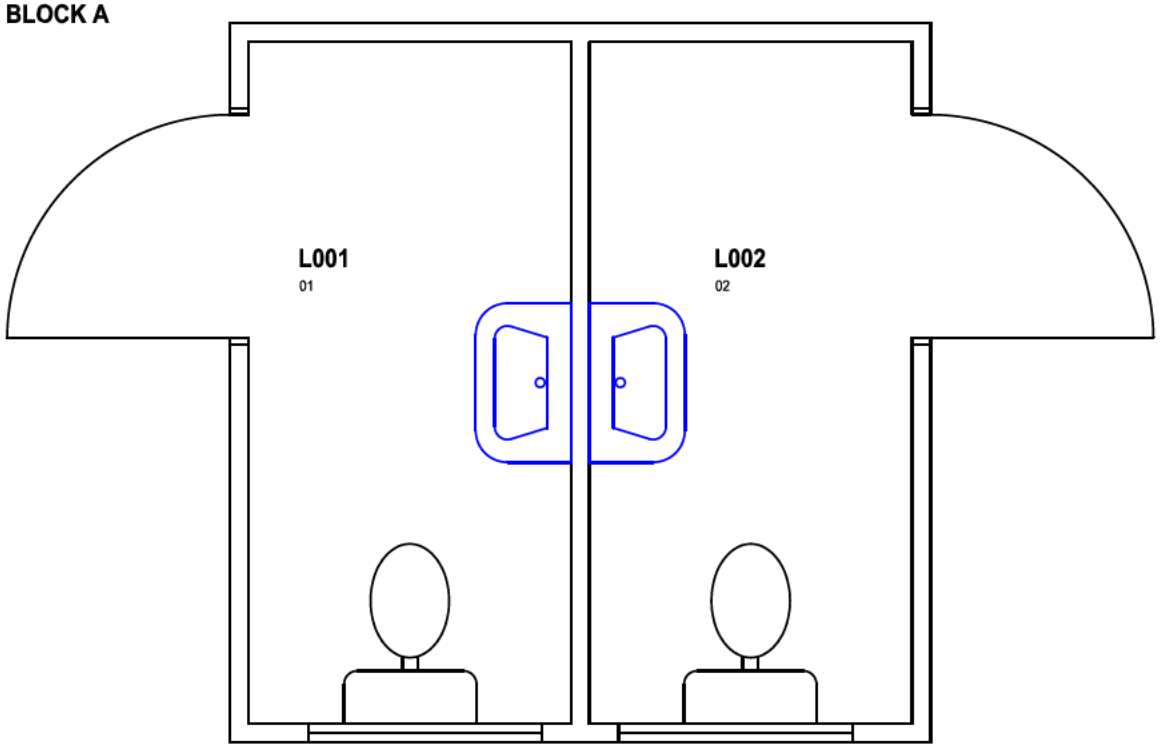
BLOCK A

Description Roof.

Score
Asbestos Type	CHRYSOTILE	1
Product Type	Cement Panels	1
Extent of Damage	Good Condition	0
Surface Treatment	Unsealed cement / Enclosed lagging or spray / Encapsulated board	1
Estimated Amount	15 m²	
Accessibility	Usually Inaccessible	
Risk Score		3

Description Walls .

Score
Asbestos Type	CHRYSOTILE	1
Product Type	Putty	1
Extent of Damage	Good Condition	0
Surface Treatment	Composite, reinforced or bonded	0
Estimated Amount	unknown	
Accessibility	Usually Inaccessible	
Risk Score		2

Recommendation	Manage & Re-inspect
Notes	Small section's visible only.

L004 - EXTERIOR
S001
S002

Recommendation	Manage & Re-inspect
Notes

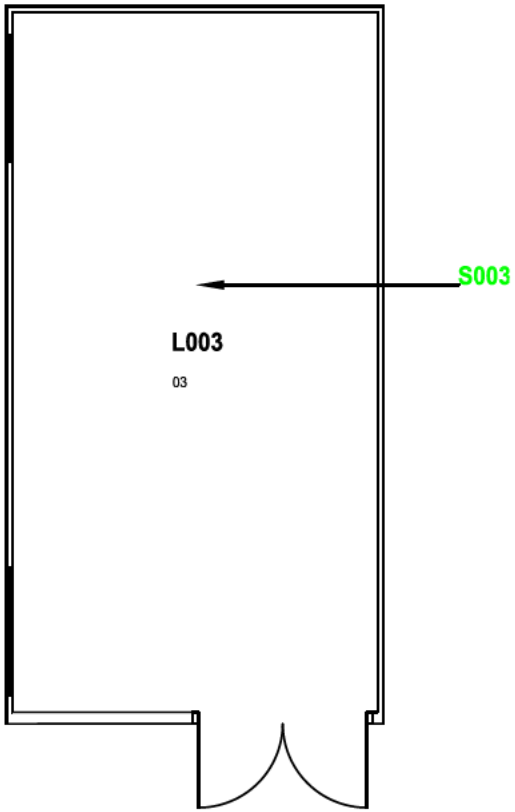
BLOCK B

Description Roof & walls.

Score
Asbestos Type	NO ASBESTOS DETECTED	-
Product Type	Felt	-
Extent of Damage	Good Condition	-
Surface Treatment	Composite, reinforced or bonded	-
Estimated Amount	30 m²	
Accessibility	Usually Inaccessible	
Risk Score		0

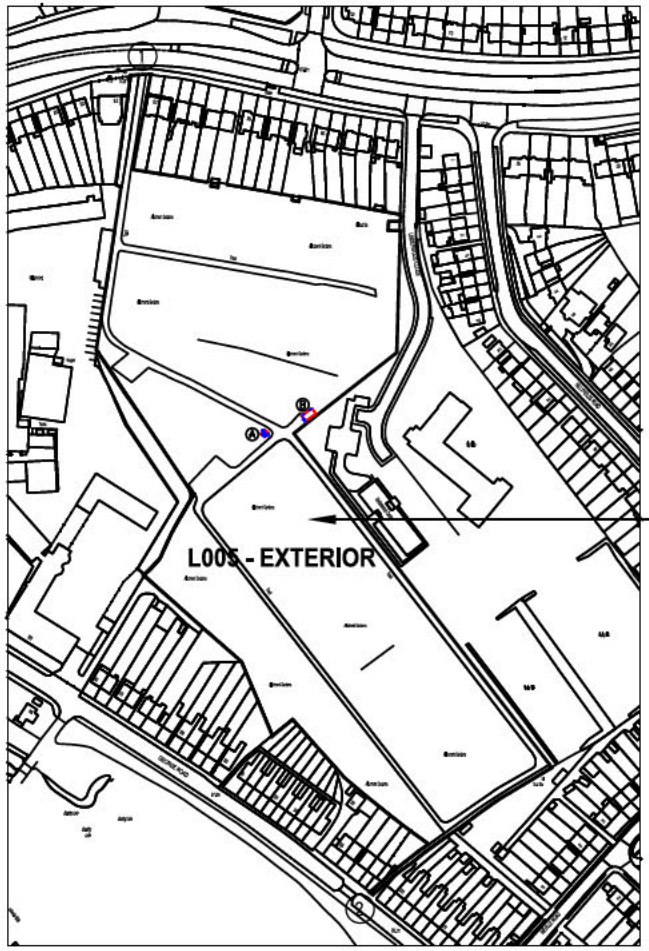
MAIN BUILDING

Description Floor.

Score
Asbestos Type	CHRYSOTILE	1
Product Type	Cement Panels	1
Extent of Damage	Good Condition	0
Surface Treatment	Unsealed cement / Enclosed lagging or spray / Encapsulated board	1
Estimated Amount	2 Item(s)	
Accessibility	Occasional Disturbance	
Risk Score		3

Recommendation	Remove and Manage
Notes	Wrapped panels to rear of Portakabin.
