Asbestos Management Survey

Meadow Road Leisure Gardens (Jubilee), B17 8DH

Report No	D-07852	**Report Issue Date**	11 October 2022
Client Name & Address	Property Services Inclusive Growth Directorate 10 Woodcock Street Birmingham B7 4BG	**Site Address**	Meadow Road Leisure Gardens (Jubilee), Meadow Road, Harborne, B17 8DH
Order Placed By	[redacted]	**Instruction Date**	21 February 2022
Order Number	[redacted]	**Project Reference**	[redacted]
Survey Date(s)	30 March 2022	**Lead Surveyor**	[redacted]

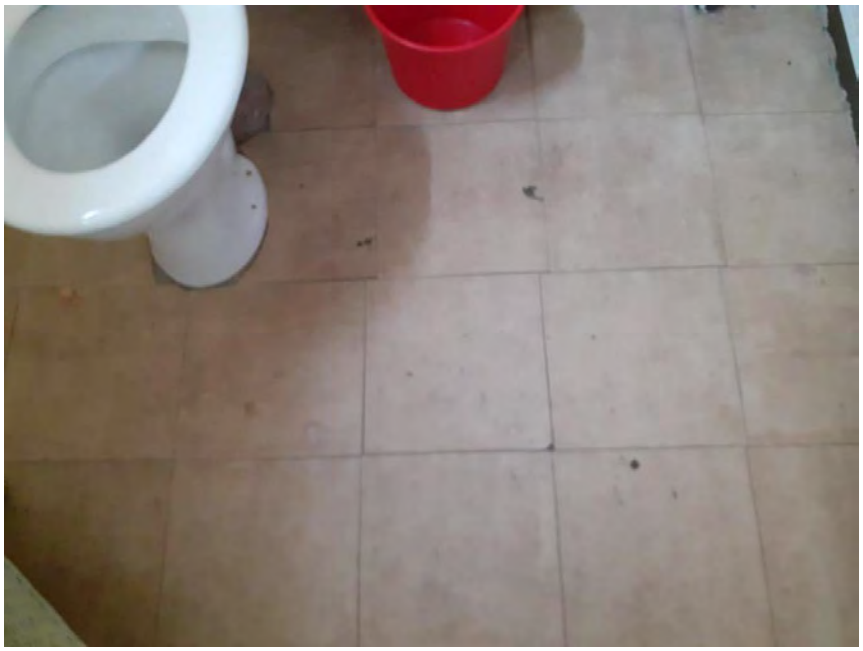
Surveyor	[redacted]		**Building**	Block A
Survey Type	Management		**Floor**	0
Survey Date	30/03/2022		**Location/ Room**	006 - Toilet 06
Next Inspection	30/03/2023		**Sample No**	S009
Level of Identification	Sample Analysed		**Inspection Ref**	720598

Description Floor.

Score
Asbestos Type	NO ASBESTOS DETECTED	-
Product Type	Floor Tiles & Adhesive	-
Extent of Damage	Low Damage	-
Surface Treatment	Composite, reinforced or bonded	-
Estimated Amount	4 m²	
Accessibility	Easily Disturbed	
Risk Score		0

Recommendation	No Recommendation Required
Notes
