Asbestos Management Survey

Pereira Road Allotments, B17 9JB

Report No	D-07854	**Report Issue Date**	11 October 2022
Client Name & Address	Property Services Inclusive Growth Directorate 10 Woodcock Street Birmingham B7 4BG	**Site Address**	Pereira Road Allotments, Pereira Road, Birmingham, B17 9JB
Order Placed By	[redacted]	**Instruction Date**	21 February 2022
Order Number	[redacted]	**Project Reference**	[redacted]
Survey Date(s)	16 March 2022	**Lead Surveyor**	[redacted]

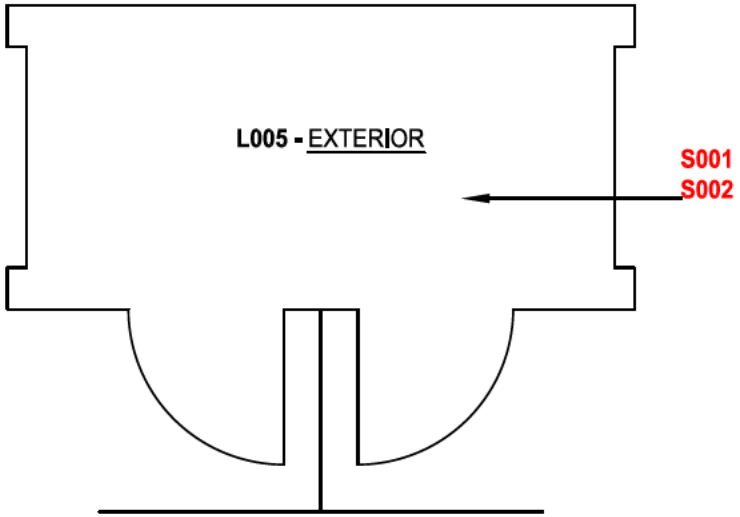
Job No: D - 07854
Drawing No: D - 07854 - 2

Surveyor	[redacted]	**Building**	Block A
Survey Type	Management	**Floor**	0
Survey Date	16/03/2022	**Location/ Room**	005 - Exterior
Next Inspection	16/03/2023	**Sample No**	S001
Level of Identification	Sample Analysed	**Inspection Ref**	715353

Description Damp Proof Course.

Score
Asbestos Type	CHRYSOTILE	1
Product Type	Bitumen Products	1
Extent of Damage	Good Condition	0
Surface Treatment	Composite, reinforced or bonded	0
Estimated Amount	10 L/M	
Accessibility	Usually Inaccessible	
Risk Score		2

Description Floor.

Score
Asbestos Type	CHRYSOTILE, CROCIDOLITE	3
Product Type	Cement Panels	1
Extent of Damage	Low Damage	1
Surface Treatment	Unsealed cement / Enclosed lagging or spray / Encapsulated board	1
Estimated Amount	1 m²	
Accessibility	Usually Inaccessible	
Risk Score		6

Recommendation	Remove and Manage
Notes	Discarded panel to rear. Site manager advised that she is going to dispose of this herself at the Council waste depot and does not require removal.

Recommendation	Manage & Re-inspect
Notes

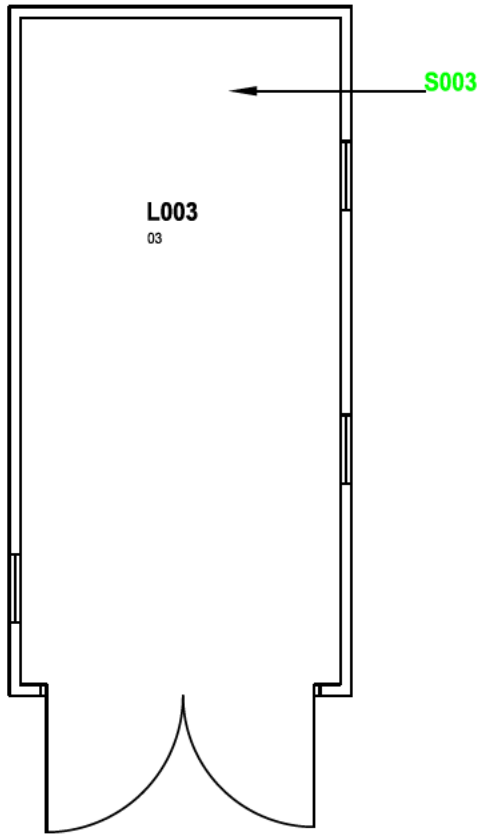
Job No: D - 07854
Drawing No: D - 07854 - 3

Surveyor	[redacted]	**Building**	Block B
Survey Type	Management	**Floor**	0
Survey Date	16/03/2022	**Location/ Room**	003 - Shed 03
Next Inspection	16/03/2023	**Sample No**	S003
Level of Identification	Sample Analysed	**Inspection Ref**	715359

Description Roof.

Score
Asbestos Type	NO ASBESTOS DETECTED	-
Product Type	Textured Coating	-
Extent of Damage	Good Condition	-
Surface Treatment	Composite, reinforced or bonded	-
Estimated Amount	30 m²	
Accessibility	Usually Inaccessible	
Risk Score		0

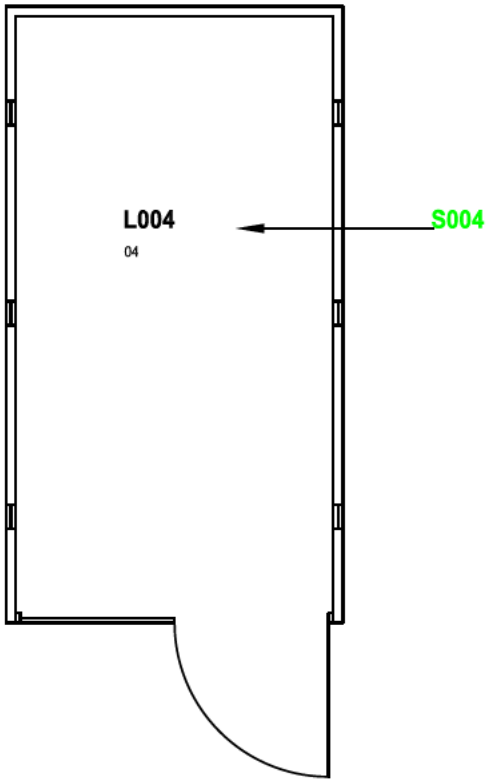
BLOCK C

Surveyor	[redacted]		**Building**	Block C
Survey Type	Management		**Floor**	0
Survey Date	16/03/2022		**Location/ Room**	004 - Shed 04
Next Inspection	16/03/2023		**Sample No**	S004
Level of Identification	Sample Analysed		**Inspection Ref**	715366

Description Roof.

Score
Asbestos Type	NO ASBESTOS DETECTED	-
Product Type	Textured Coating	-
Extent of Damage	Good Condition	-
Surface Treatment	Composite, reinforced or bonded	-
Estimated Amount	15 m²	
Accessibility	Usually Inaccessible	
Risk Score		0
