Asbestos Management Survey

Tennal Lane Allotments, B32 2HN

Report No	D-07858	**Report Issue Date**	26 August 2022
Client Name & Address	Property Services Inclusive Growth Directorate 10 Woodcock Street Birmingham B7 4BG	**Site Address**	Tennal Lane Allotments, Tennal Lane, Birmingham, B32 2HN
Order Placed By	[redacted]	**Instruction Date**	21 February 2022
Order Number	[redacted]	**Project Reference**	[redacted]
Survey Date(s)	4 April 2022	**Lead Surveyor**	[redacted]

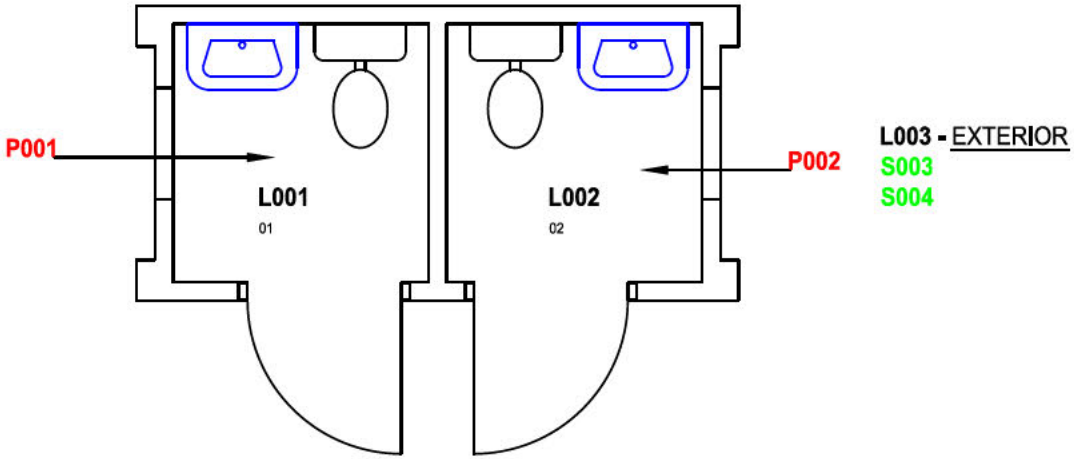
Job No: D - 07858
Drawing No: D - 07858 - 1

Building	Floor	Location/ Room	Position	Item	Sample No	Inspection Ref	Risk Score
Allotments	0	001 - Toilet	No Access	Presumed Asbestos	P001	725279	12
Allotments	0	002 - Toilet	No Access	Presumed Asbestos	P002	725280	12

Building	Location / Room	Description	Notes
Allotments	Floor - 0 001 - Toilet	No Access.	Presumed due to no access. No key available at time of survey.
Allotments	Floor - 0 002 - Toilet	No Access.	Presumed due to no access. No key available at time of survey.
