Asbestos Management Survey

Uffculme Allotments, B13 8QB

Report No	D-07860	**Report Issue Date**	9 March 2023
Client Name & Address	Property Services Place, Prosperity & Sustainability 10 Woodcock Street Birmingham B7 4BG	**Site Address**	Uffculme Allotments, Alcester Road, Birmingham, B13 8QB
Order Placed By	[redacted]	**Instruction Date**	21 February 2022
Order Number	[redacted]	**Project Reference**	[redacted]
Survey Date(s)	on 21/02/2023	**Lead Surveyor**	[redacted]

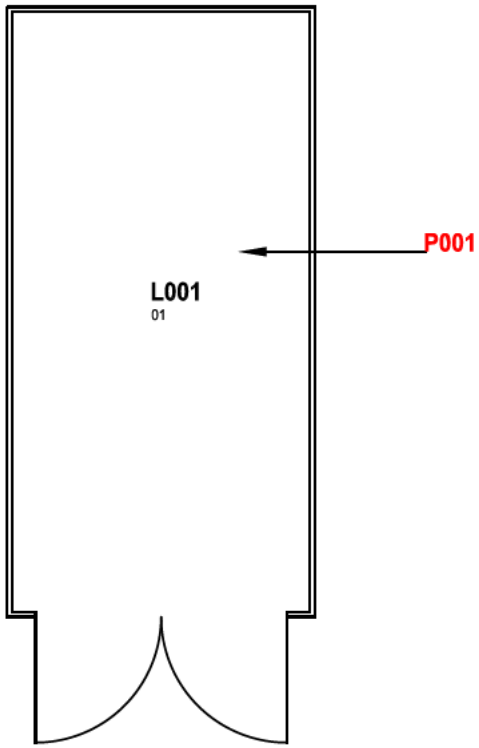
Job No: D - 07860
Drawing No: D - 07860 - 1

Building	Location / Room	Description	Notes
Allotments	Floor - 0 0001 - Store	No Access .	Presumed due to no access. No key available at time of survey.
