Asbestos Management Survey

West Heath Allotments, B31 3LN

Report No	D-07892	**Report Issue Date**	26 August 2022
Client Name & Address	Property Services Inclusive Growth Directorate 10 Woodcock Street Birmingham B7 4BG	**Site Address**	West Heath Allotments, The Fordrough, Northfield, Birmingham, B31 3LN
Order Placed By	[redacted]	**Instruction Date**	9 March 2022
Order Number	[redacted]	**Project Reference**	[redacted]
Survey Date(s)	22 March 2022	**Lead Surveyor**	[redacted]

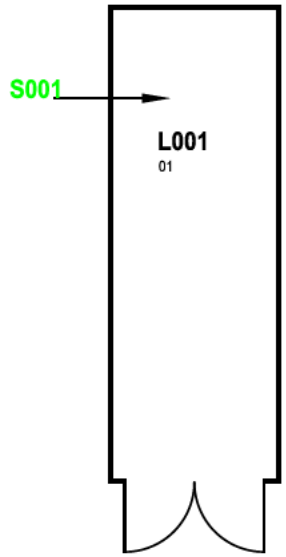
BLOCK A

Surveyor	[redacted]		**Building**	Block A
Survey Type	Management		**Floor**	0
Survey Date	22/03/2022		**Location/ Room**	001 - Shed 01
Next Inspection	22/03/2023		**Sample No**	S001
Level of Identification	Sample Analysed		**Inspection Ref**	718697

Description Walls .

Score
Asbestos Type	NO ASBESTOS DETECTED	-
Product Type	Putty	-
Extent of Damage	Low Damage	-
Surface Treatment	Composite, reinforced or bonded	-
Estimated Amount	30 L/M	
Accessibility	Usually Inaccessible	
Risk Score		0

Recommendation	No Recommendation Required
Notes

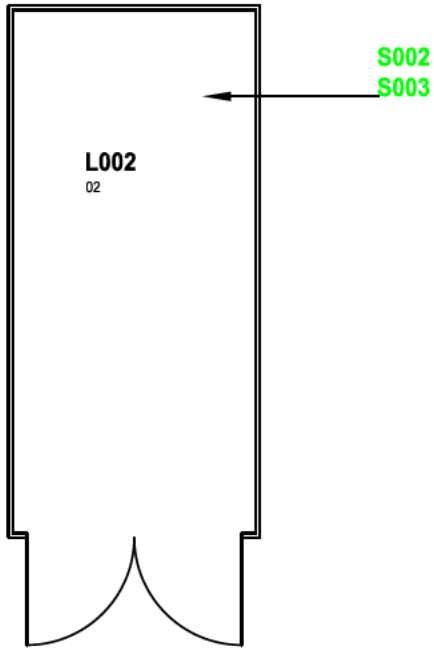
BLOCK B

Surveyor	[redacted]		**Building**	Block B
Survey Type	Management		**Floor**	0
Survey Date	22/03/2022		**Location/ Room**	002 - Shed 02
Next Inspection	22/03/2023		**Sample No**	S002
Level of Identification	Sample Analysed		**Inspection Ref**	718702

Description Roof.

Score
Asbestos Type	NO ASBESTOS DETECTED	-
Product Type	Textured Coating	-
Extent of Damage	Good Condition	-
Surface Treatment	Composite, reinforced or bonded	-
Estimated Amount	25 m²	
Accessibility	Usually Inaccessible	
Risk Score		0

Surveyor	[redacted]		**Building**	Block B
Survey Type	Management		**Floor**	0
Survey Date	22/03/2022		**Location/ Room**	002 - Shed 02
Next Inspection	22/03/2023		**Sample No**	S003
Level of Identification	Sample Analysed		**Inspection Ref**	718707

Description Walls .

Score
Asbestos Type	NO ASBESTOS DETECTED	-
Product Type	Putty	-
Extent of Damage	Good Condition	-
Surface Treatment	Composite, reinforced or bonded	-
Estimated Amount	25 L/M	
Accessibility	Usually Inaccessible	
Risk Score		0
