Asbestos Management Survey

Wheelers Lane Allotments, B13 0AB

Report No	D-07893	**Report Issue Date**	6 January 2023
Client Name & Address	Property Services Inclusive Growth Directorate 10 Woodcock Street Birmingham B7 4BG	**Site Address**	Wheelers Lane Allotments, Wheelers Lane, Birmingham, B13 0AB
Order Placed By	[redacted]	**Instruction Date**	9 March 2022
Order Number	[redacted]	**Project Reference**	[redacted]
Survey Date(s)	7 April 2022	**Lead Surveyor**	[redacted]

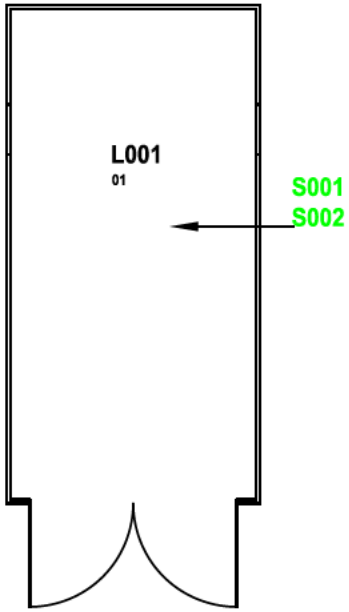
Job No: D - 07893
Drawing No: D - 07893 - 1

Surveyor	[redacted]	**Building**	Block A
Survey Type	Management	**Floor**	0
Survey Date	07/04/2022	**Location/ Room**	001 - Shed 01
Next Inspection	07/04/2023	**Sample No**	S001
Level of Identification	Sample Analysed	**Inspection Ref**	723922

Description Roof.

Score
Asbestos Type	NO ASBESTOS DETECTED	-
Product Type	Textured Coating	-
Extent of Damage	Good Condition	-
Surface Treatment	Composite, reinforced or bonded	-
Estimated Amount	25 m²	
Accessibility	Usually Inaccessible	
Risk Score		0

Surveyor	[redacted]		**Building**	Block A
Survey Type	Management		**Floor**	0
Survey Date	07/04/2022		**Location/ Room**	001 - Shed 01
Next Inspection	07/04/2023		**Sample No**	S002
Level of Identification	Sample Analysed		**Inspection Ref**	723928

Description Walls .

Score
Asbestos Type	NO ASBESTOS DETECTED	-
Product Type	Putty	-
Extent of Damage	Low Damage	-
Surface Treatment	Composite, reinforced or bonded	-
Estimated Amount	30 L/M	
Accessibility	Occasional Disturbance	
Risk Score		0

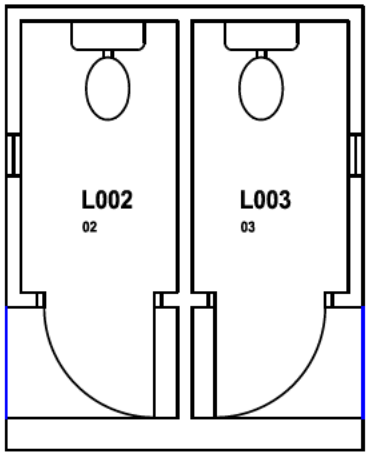
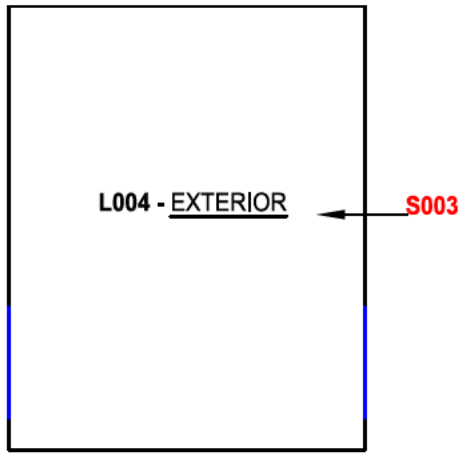
Job No: D - 07893
Drawing No: D - 07893 - 3

Surveyor	[redacted]	**Building**	Block B
Survey Type	Management	**Floor**	External
Survey Date	07/04/2022	**Location/ Room**	004 - Toilet Block
Next Inspection	07/04/2023	**Sample No**	S003
Level of Identification	Sample Analysed	**Inspection Ref**	723939

Description Damp Proof Course.

Score
Asbestos Type	CHRYSOTILE	1
Product Type	Bitumen Products	1
Extent of Damage	Good Condition	0
Surface Treatment	Composite, reinforced or bonded	0
Estimated Amount	10 L/M	
Accessibility	Usually Inaccessible	
Risk Score		2

Recommendation	Manage & Re-inspect
Notes
