Asbestos Management Survey

Bells Sports Field Allotment, B38 8QR

Report No	D-07896	**Report Issue Date**	24 February 2023
Client Name & Address	Property Services Place, Prosperity & Sustainability 10 Woodcock Street Birmingham B7 4BG	**Site Address**	Bells Sports Field Allotment, Redditch Road, Birmingham, B38 8QR
Order Placed By	[redacted]	**Instruction Date**	9 March 2022
Order Number	[redacted]	**Project Reference**	[redacted]
Survey Date(s)	on 04/04/2022	**Lead Surveyor**	[redacted]

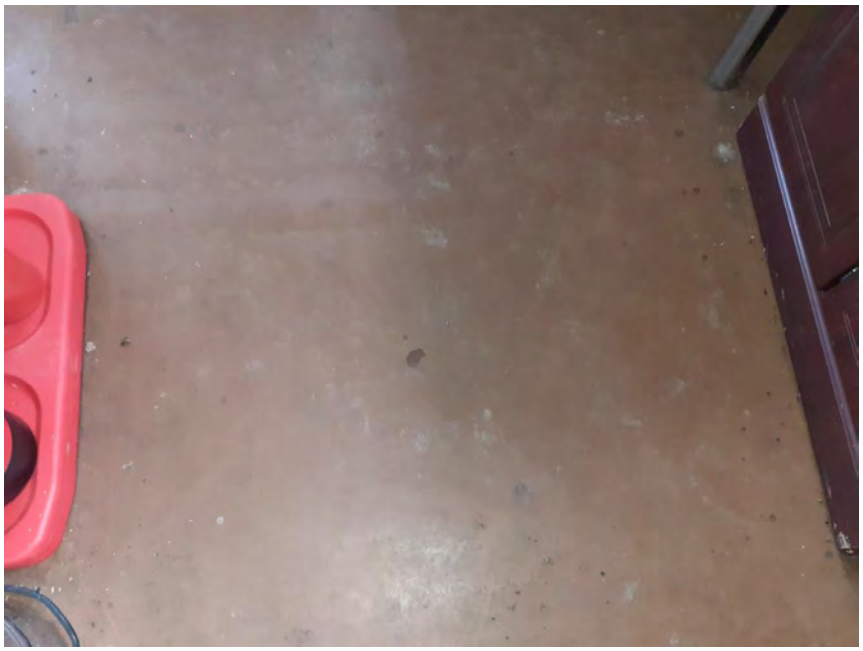
Surveyor	[redacted]	**Building**	Pavilion
Survey Type	Management	**Floor**	0
Survey Date	04/04/2022	**Location/ Room**	013 - Kitchen 01
Next Inspection	04/04/2023	**Sample No**	X012
Level of Identification	Strongly Presumed	**Inspection Ref**	721372

Description Vinyl Flooring. Visually consistent with Sample 12.

Score
Asbestos Type	NO ASBESTOS DETECTED	-
Product Type	Vinyl Products	-
Extent of Damage	Low Damage	-
Surface Treatment	Composite, reinforced or bonded	-
Estimated Amount	6 m²	
Accessibility	Routinely Disturbed	
Risk Score		0

Recommendation	No Recommendation Required
Notes
