Asbestos Management Survey

Camp Lane (Uplands) Allotment, B21 8EZ

Report No	D-07897	**Report Issue Date**	14 March 2023
Client Name & Address	Property Services Place, Prosperity & Sustainability 10 Woodcock Street Birmingham B7 4BG	**Site Address**	Camp Lane (Uplands) Allotment, Oxhill Road, Birmingham, B21 8EZ
Order Placed By	[redacted]	**Instruction Date**	9 March 2022
Order Number	[redacted]	**Project Reference**	[redacted]
Survey Date(s)	on 11/04/2022	**Lead Surveyor**	[redacted]

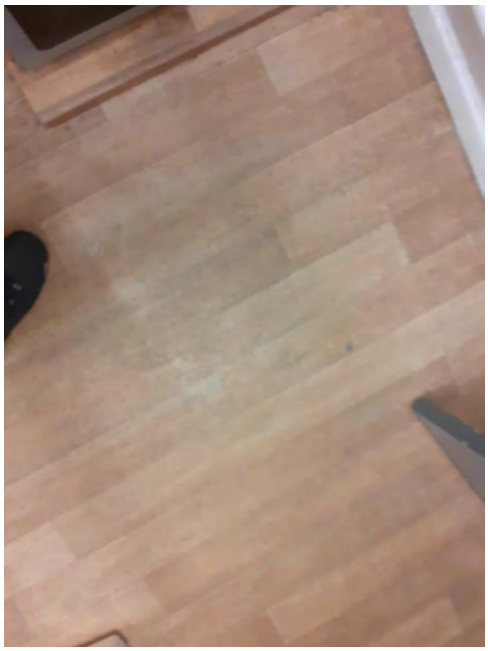
Surveyor	[redacted]	**Building**	Block C
Survey Type	Management	**Floor**	0
Survey Date	11/04/2022	**Location/ Room**	006 - Kitchen 06
Next Inspection	11/04/2023	**Sample No**	S001
Level of Identification	Sample Analysed	**Inspection Ref**	725650

Description Floor below vinyl.

Score
Asbestos Type	CHRYSOTILE	1
Product Type	Bitumen Products	1
Extent of Damage	Low Damage	1
Surface Treatment	Composite, reinforced or bonded	0
Estimated Amount	8 m²	
Accessibility	Usually Inaccessible	
Risk Score		3

Recommendation	Manage & Re-inspect
Notes	Remaining adhesive.

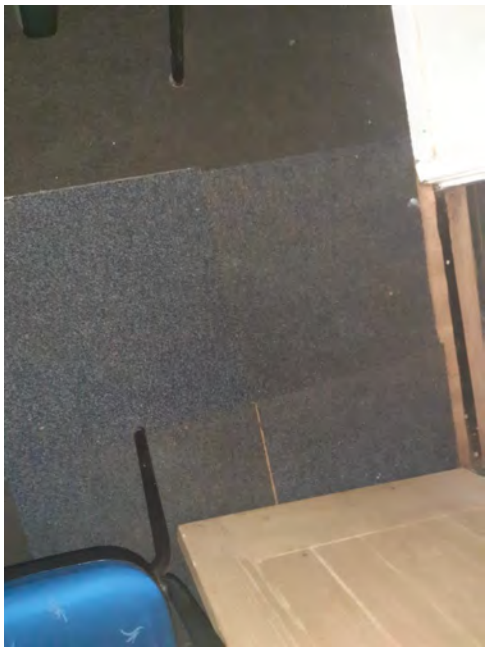
Surveyor	[redacted]	**Building**	Block C
Survey Type	Management	**Floor**	0
Survey Date	11/04/2022	**Location/ Room**	007 - Office 07
Next Inspection	11/04/2023	**Sample No**	X002
Level of Identification	Strongly Presumed	**Inspection Ref**	725667

Description Floor below vinyl. Visually consistent with Sample 2.

Score
Asbestos Type	CHRYSOTILE (Chrysotile In Tile And Adhesive)	1
Product Type	Floor Tiles & Adhesive	1
Extent of Damage	Low Damage	1
Surface Treatment	Composite, reinforced or bonded	0
Estimated Amount	15 m²	
Accessibility	Usually Inaccessible	
Risk Score		3

Recommendation	Manage & Re-inspect
Notes
