Asbestos Management Survey

Fox Hollies Nine Stiles Allotments, B27 7NX

Report No	D-07898	**Report Issue Date**	10 October 2022
Client Name & Address	Property Services Inclusive Growth Directorate 10 Woodcock Street Birmingham B7 4BG	**Site Address**	Fox Hollies Nine Stiles Allotments, Fox Hollies Road, Acocks Green, Birmingham, B27 7NX
Order Placed By	[redacted]	**Instruction Date**	9 March 2022
Order Number	[redacted]	**Project Reference**	[redacted]
Survey Date(s)	28 March 2022	**Lead Surveyor**	[redacted]

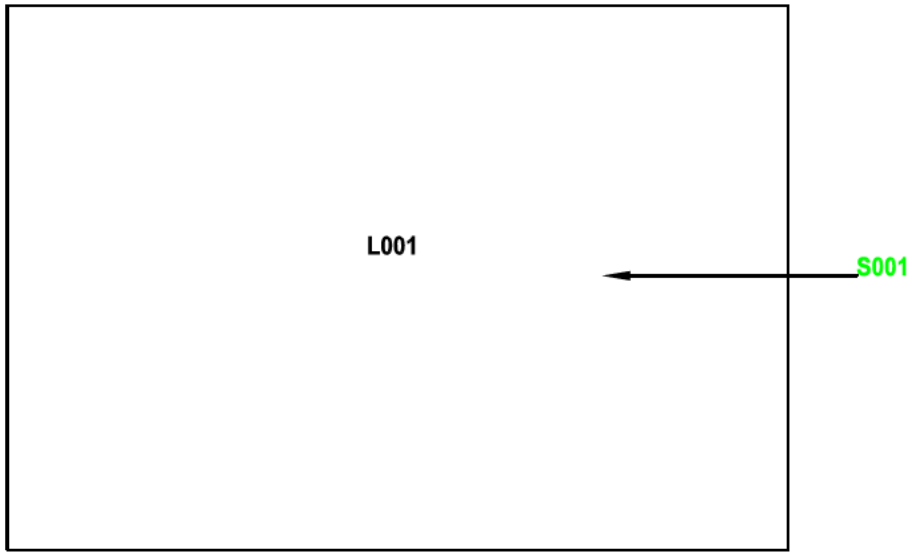
Job No: D - 07898
Drawing No: D - 07898 - 1

Surveyor	[redacted]	**Building**	Shed Store
Survey Type	Management	**Floor**	0
Survey Date	28/03/2022	**Location/ Room**	001 - Store
Next Inspection	28/03/2023	**Sample No**	S001
Level of Identification	Sample Analysed	**Inspection Ref**	720124

Description Ceiling.

Score
Asbestos Type	NO ASBESTOS DETECTED	-
Product Type	Bitumen Products	-
Extent of Damage	Good Condition	-
Surface Treatment	Composite, reinforced or bonded	-
Estimated Amount	Unknown	
Accessibility	Occasional Disturbance	
Risk Score		0

Recommendation	No Recommendation Required
Notes	Bitumen Adhesive residue on Ceiling.

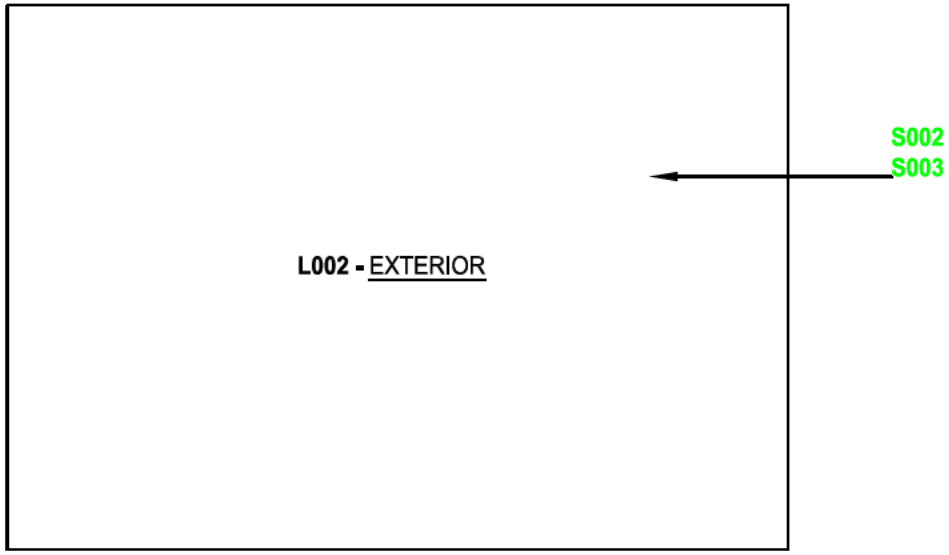
Job No: D - 07898
Drawing No: D - 07898 - 2

Surveyor	[redacted]	**Building**	Shed Store
Survey Type	Management	**Floor**	External
Survey Date	28/03/2022	**Location/ Room**	002 - Store Exterior Perimeter & Roof
Next Inspection	28/03/2023	**Sample No**	S002
Level of Identification	Sample Analysed	**Inspection Ref**	720129

Description Roof Lining.

Score
Asbestos Type	NO ASBESTOS DETECTED	-
Product Type	Textiles / Cloth	-
Extent of Damage	Good Condition	-
Surface Treatment	Composite, reinforced or bonded	-
Estimated Amount	Unknown	
Accessibility	Usually Inaccessible	
Risk Score		0

Recommendation	No Recommendation Required
Notes	Fibrous roof lining beneath metal corrugated roof sheets.

Surveyor	[redacted]	**Building**	Shed Store
Survey Type	Management	**Floor**	External
Survey Date	28/03/2022	**Location/ Room**	002 - Store Exterior Perimeter & Roof
Next Inspection	28/03/2023	**Sample No**	S003
Level of Identification	Sample Analysed	**Inspection Ref**	720130

Description Wall Putty.

Score
Asbestos Type	NO ASBESTOS DETECTED	-
Product Type	Putty	-
Extent of Damage	Good Condition	-
Surface Treatment	Composite, reinforced or bonded	-
Estimated Amount	Unknown	
Accessibility	Usually Inaccessible	
Risk Score		0

Recommendation	No Recommendation Required
Notes	Putty/Sealant between concrete wall Panels.
