Asbestos Management Survey

Hermitage Farm (Uplands) Allotment, B21 8ET

Report No	D-07899	**Report Issue Date**	6 January 2023
Client Name & Address	Property Services Inclusive Growth Directorate 10 Woodcock Street Birmingham B7 4BG	**Site Address**	Hermitage Farm (Uplands) Allotment, Oxhill Road, Birmingham, B21 8ET
Order Placed By	[redacted]	**Instruction Date**	9 March 2022
Order Number	[redacted]	**Project Reference**	[redacted]
Survey Date(s)	11 April 2022	**Lead Surveyor**	[redacted]

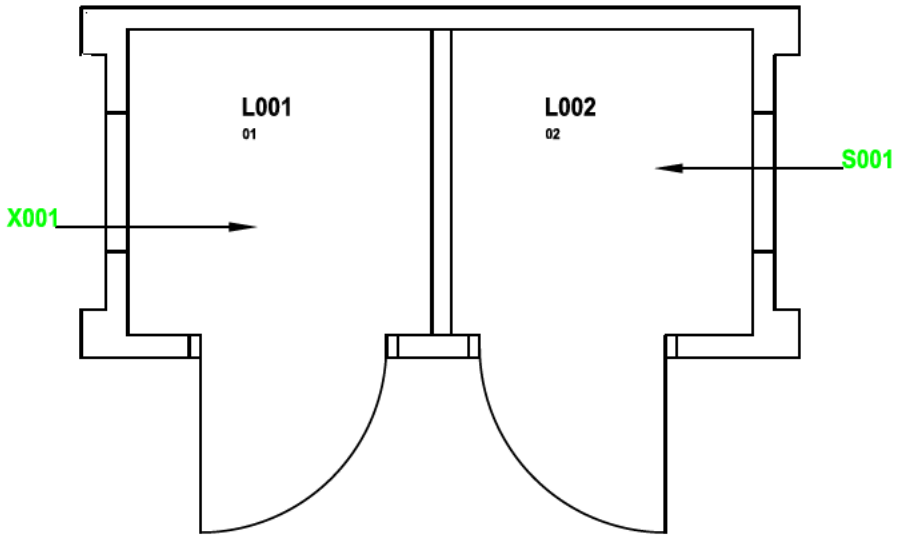
Job No: D - 07899
Drawing No: D - 07899 - 1

Surveyor	[redacted]		**Building**	Block A
Survey Type	Management		**Floor**	0
Survey Date	11/04/2022		**Location/ Room**	001 - Toilet 01
Next Inspection	11/04/2023		**Sample No**	X001
Level of Identification	Strongly Presumed		**Inspection Ref**	725606

Description Ceiling panels . Visually consistent with Sample 1.

Score
Asbestos Type	NO ASBESTOS DETECTED	-
Product Type	Board	-
Extent of Damage	Medium Damage	-
Surface Treatment	Unsealed board or cloth / Encapsulated lagging or spray	-
Estimated Amount	4 m²	
Accessibility	Usually Inaccessible	
Risk Score		0

Surveyor	[redacted]		**Building**	Block A
Survey Type	Management		**Floor**	0
Survey Date	11/04/2022		**Location/ Room**	002 - Toilet 02
Next Inspection	11/04/2023		**Sample No**	S001
Level of Identification	Sample Analysed		**Inspection Ref**	725602

Description Ceiling panels .

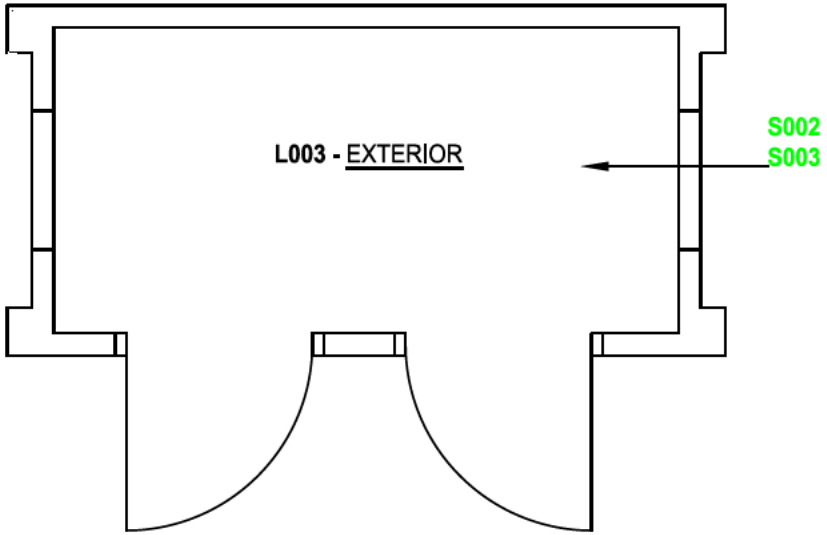
Job No: D - 07899
Drawing No: D - 07899 - 2

Surveyor	[redacted]		**Building**	Block A
Survey Type	Management		**Floor**	External
Survey Date	11/04/2022		**Location/ Room**	003 - Exterior
Next Inspection	11/04/2023		**Sample No**	S002
Level of Identification	Sample Analysed		**Inspection Ref**	725610

Description Door & window frames .

Score
Asbestos Type	NO ASBESTOS DETECTED	-
Product Type	Putty	-
Extent of Damage	Low Damage	-
Surface Treatment	Composite, reinforced or bonded	-
Estimated Amount	6 L/M	
Accessibility	Usually Inaccessible	
Risk Score		0

Surveyor	[redacted]	**Building**	Block A
Survey Type	Management	**Floor**	External
Survey Date	11/04/2022	**Location/ Room**	003 - Exterior
Next Inspection	11/04/2023	**Sample No**	S003
Level of Identification	Sample Analysed	**Inspection Ref**	725617

Description Roof.

Score
Asbestos Type	NO ASBESTOS DETECTED	-
Product Type	Felt	-
Extent of Damage	Low Damage	-
Surface Treatment	Composite, reinforced or bonded	-
Estimated Amount	10 m²	
Accessibility	Usually Inaccessible	
Risk Score		0
