Asbestos Management Survey

The Leys Allotments, B45 9WA

Report No	D-07900	**Report Issue Date**	24 March 2023
Client Name & Address	Property Services Place, Prosperity & Sustainability 10 Woodcock Street Birmingham B7 4BG	**Site Address**	The Leys Allotments, Leybrook Road, Birmingham, B45 9WA
Order Placed By	[redacted]	**Instruction Date**	9 March 2022
Order Number	[redacted]	**Project Reference**	[redacted]
Survey Date(s)	on 25/04/2022	**Lead Surveyor**	[redacted]

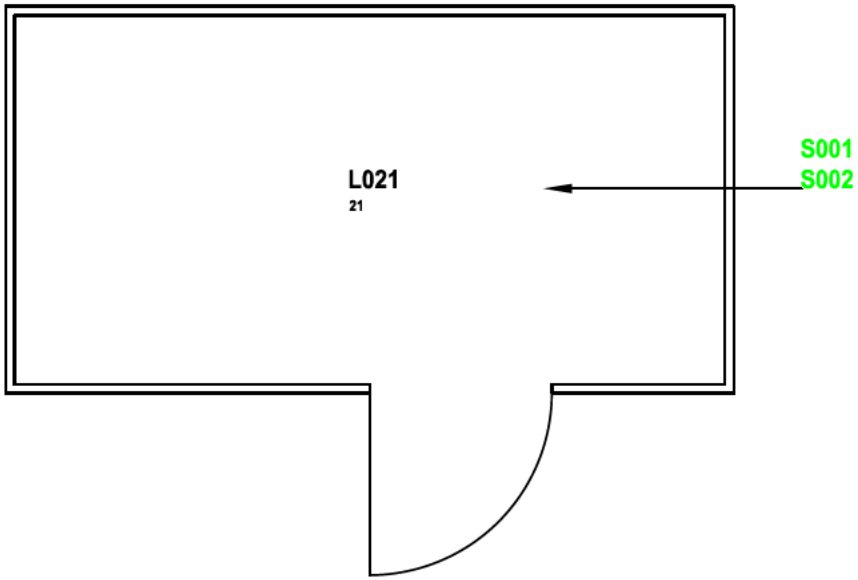
BLOCK C

Score
Asbestos Type	NO ASBESTOS DETECTED	-
Product Type	Textured Coating	-
Extent of Damage	Low Damage	-
Surface Treatment	Composite, reinforced or bonded	-
Estimated Amount	25 m²	
Accessibility	Usually Inaccessible	
Risk Score		0

Score
Asbestos Type	NO ASBESTOS DETECTED	-
Product Type	Putty	-
Extent of Damage	Good Condition	-
Surface Treatment	Composite, reinforced or bonded	-
Estimated Amount	40 L/M	
Accessibility	Occasional Disturbance	
Risk Score		0

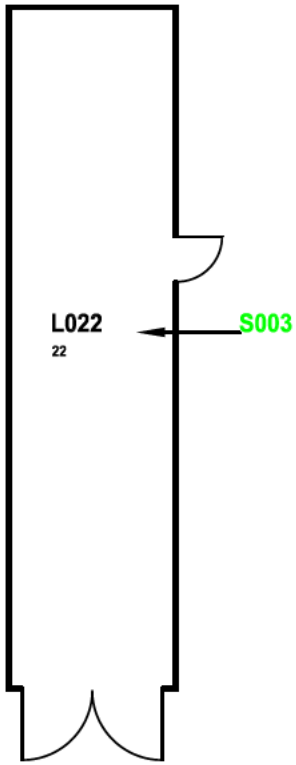
BLOCK D

Score
Asbestos Type	NO ASBESTOS DETECTED	-
Product Type	Putty	-
Extent of Damage	Good Condition	-
Surface Treatment	Composite, reinforced or bonded	-
Estimated Amount	80 L/M	
Accessibility	Occasional Disturbance	
Risk Score		0

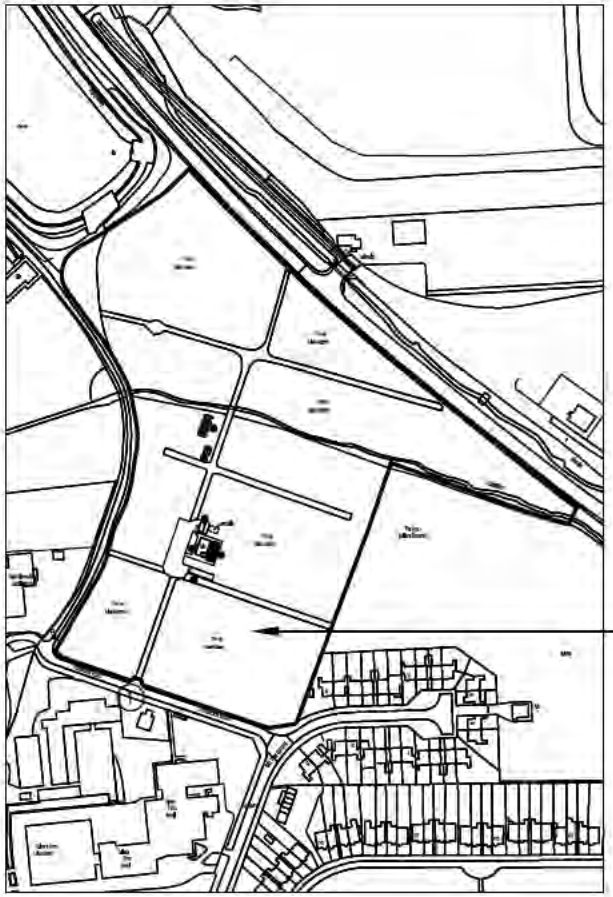
Main Building

Score
Asbestos Type	NO ASBESTOS DETECTED	-
Product Type	Cement Panels	-
Extent of Damage	High Damage	-
Surface Treatment	Unsealed cement / Enclosed lagging or spray / Encapsulated board	-
Estimated Amount	15 m²	
Accessibility	Easily Disturbed	
Risk Score		0

Recommendation	No Recommendation Required
Notes	Cement panels to Plot 47b. Asked to test due to concerns from tenants.
