Asbestos Management Survey

May Lane Allotments Gardens, B14 4AG

Report No	D-07901	**Report Issue Date**	26 April 2023
Client Name & Address	Property Services Place, Prosperity & Sustainability 10 Woodcock Street Birmingham B7 4BG	**Site Address**	May Lane Allotments Gardens, May Lane, Birmingham, B14 4AG
Order Placed By	[redacted]	**Instruction Date**	9 March 2022
Order Number	[redacted]	**Project Reference**	[redacted]
Survey Date(s)	24 January 2023	**Lead Surveyor**	[redacted]

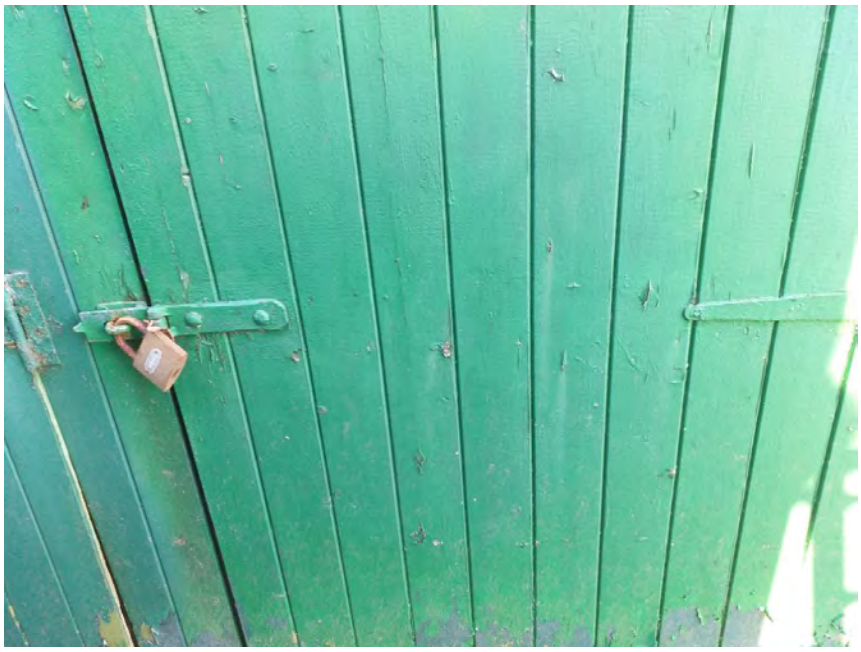
Surveyor	[redacted]	**Building**	Lockers A
Survey Type	Management	**Floor**	0
Survey Date	24/01/2023	**Location/ Room**	0004 - Locker
Next Inspection	24/01/2024	**Sample No**	P005
Level of Identification	Presumed	**Inspection Ref**	808579

Description No Access.

Score
Asbestos Type	Presumed Asbestos	-
Product Type		-
Extent of Damage		-
Surface Treatment		-
Estimated Amount		
Accessibility		
Risk Score		12

Recommendation	Inspection Required
Notes	Presumed due to no access. No key available at time of survey.

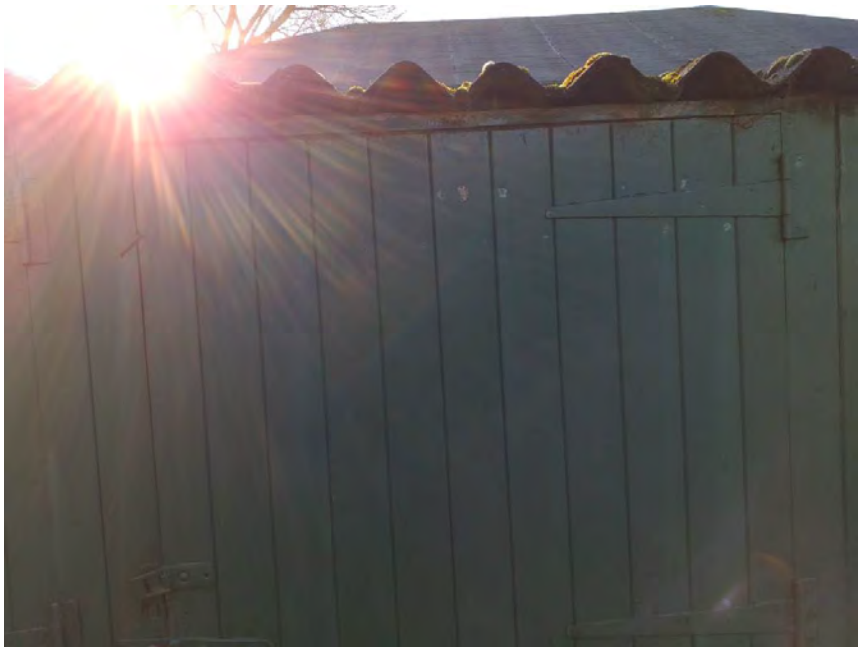
Surveyor	[redacted]		**Building**	Lockers A
Survey Type	Management		**Floor**	0
Survey Date	24/01/2023		**Location/ Room**	0018 - Locker
Next Inspection	24/01/2024		**Sample No**	P019
Level of Identification	Presumed		**Inspection Ref**	808593

Description No Access.

Score
Asbestos Type	Presumed Asbestos	-
Product Type		-
Extent of Damage		-
Surface Treatment		-
Estimated Amount		
Accessibility		
Risk Score		12

Recommendation	Inspection Required
Notes	Presumed due to no access. No key available at time of survey.

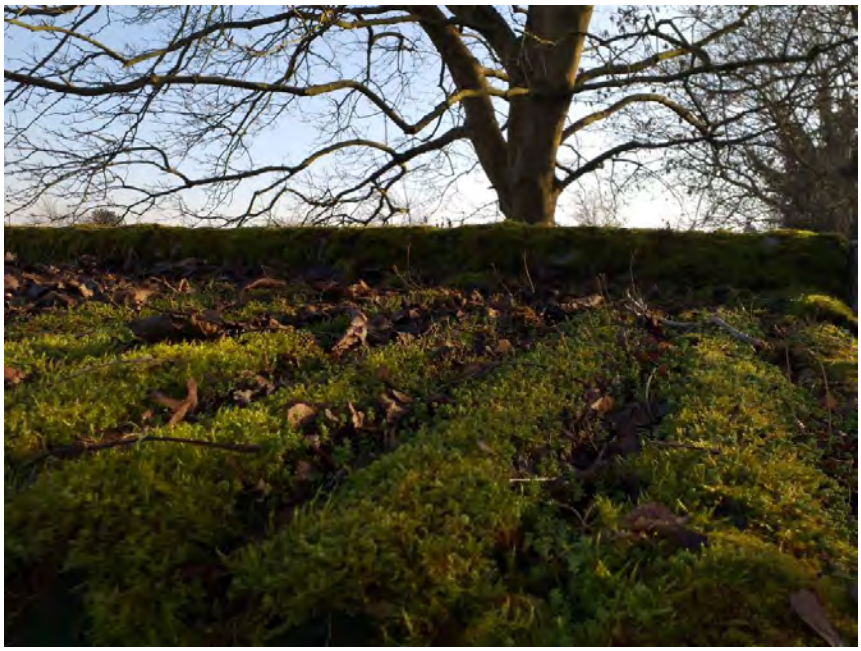
Surveyor	[redacted]	**Building**	Lockers C
Survey Type	Management	**Floor**	External
Survey Date	24/01/2023	**Location/ Room**	0046 - Exterior Perimeter & Roof
Next Inspection	24/01/2024	**Sample No**	S050
Level of Identification	Sample Analysed	**Inspection Ref**	808652

Description Roof.

Score
Asbestos Type	CHRYSOTILE	1
Product Type	Cement Products	1
Extent of Damage	Good Condition	0
Surface Treatment	Unsealed cement / Enclosed lagging or spray / Encapsulated board	1
Estimated Amount	8 m²	
Accessibility	Occasional Disturbance	
Risk Score		3

Recommendation	Manage & Re-inspect
Notes

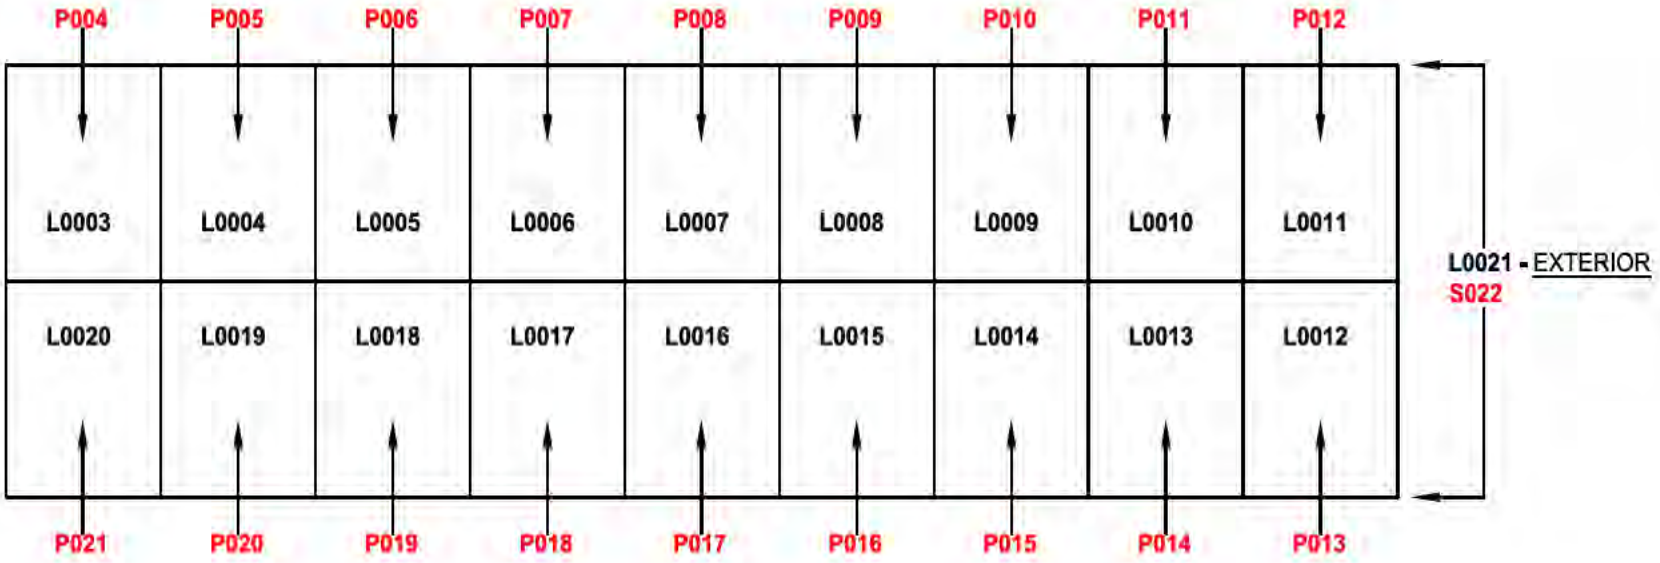
LOCKERS A

Building	Floor	Location / Room	Sample No	Position	Product Type	Damage	Surface Treatment	Asbestos Type	Estimated Amount	Access	Score	Recommendations
Lockers A	0	0017 - Locker	P018	No Access	Presumed Asbestos						12	No Access - Inspection Required
Lockers A	0	0018 - Locker	P019	No Access	Presumed Asbestos						12	No Access - Inspection Required
Lockers A	0	0019 - Locker	P020	No Access	Presumed Asbestos						12	No Access - Inspection Required
Lockers A	0	0020 - Locker	P021	No Access	Presumed Asbestos						12	No Access - Inspection Required
Lockers B	0	0027 - Locker	P031	No Access	Presumed Asbestos						12	No Access - Inspection Required
Lockers B	0	0028 - Locker	P032	No Access	Presumed Asbestos						12	No Access - Inspection Required
Lockers B	0	0029 - Locker	P033	No Access	Presumed Asbestos						12	No Access - Inspection Required
Lockers B	0	0030 - Locker	P034	No Access	Presumed Asbestos						12	No Access - Inspection Required

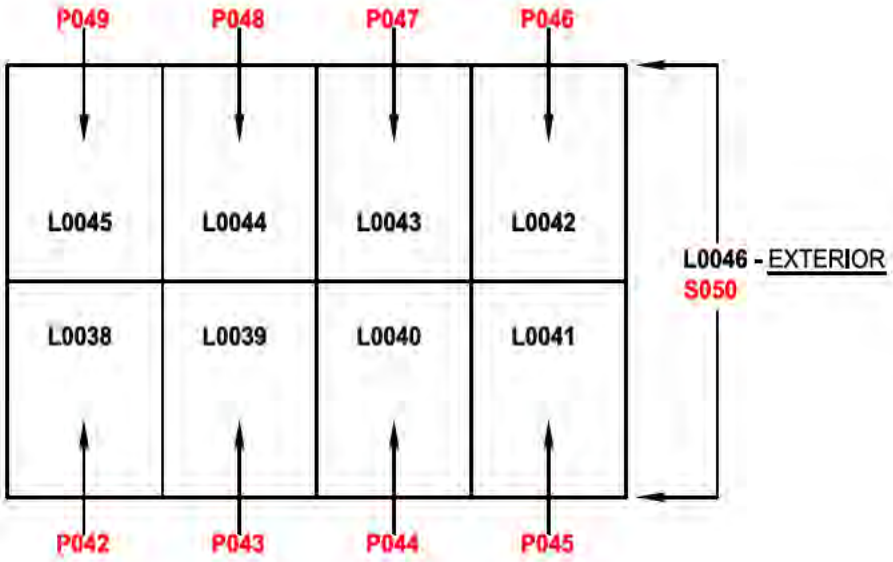
LOCKERS C

Building	Floor	Location / Room	Sample No	Position	Product Type	Damage	Surface Treatment	Asbestos Type	Estimated Amount	Access	Score	Recommendations
Lockers C	0	0039 - Locker	P043	No Access	Presumed Asbestos						12	No Access - Inspection Required
Lockers C	0	0040 - Locker	P044	No Access	Presumed Asbestos						12	No Access - Inspection Required
Lockers C	0	0041 - Locker	P045	No Access	Presumed Asbestos						12	No Access - Inspection Required
Lockers C	0	0042 - Locker	P046	No Access	Presumed Asbestos						12	No Access - Inspection Required
Lockers C	0	0043 - Locker	P047	No Access	Presumed Asbestos						12	No Access - Inspection Required
Lockers C	0	0044 - Locker	P048	No Access	Presumed Asbestos						12	No Access - Inspection Required
Lockers C	0	0045 - Locker	P049	No Access	Presumed Asbestos						12	No Access - Inspection Required
Lockers C	External	0046 - Exterior Perimeter & Roof	S050	Roof	Cement Products	Good Condition	Unsealed cement / Enclosed lagging or spray / Encapsulated board	Chrysotile	8 m²	Occasional Disturbance	3	Manage & Re-inspect

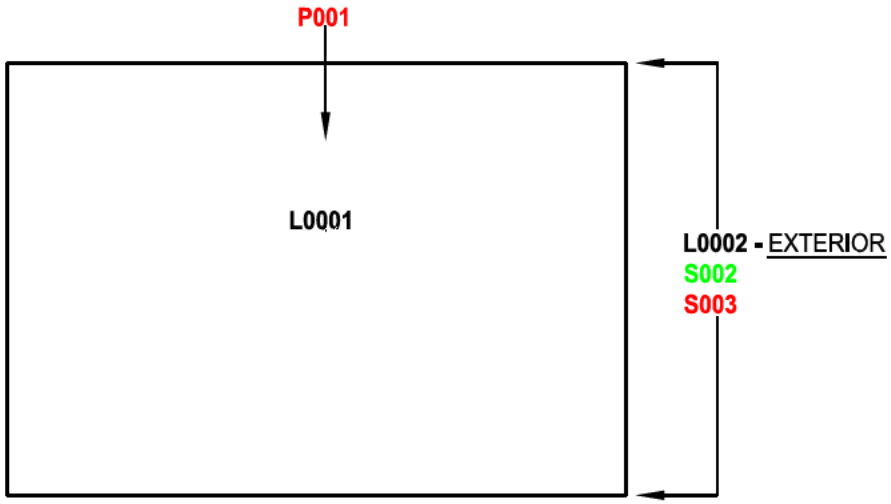
PAVILION

Pavilion	0	0001 - Pavilion	P001	No Access	Presumed Asbestos						12	No Access - Inspection Required
Pavilion	External	0002 - Exterior Perimeter & Roof	S003	Damp Proof Course	Bitumen Products	Good Condition	Composite, reinforced or bonded	Chrysotile	Unknown	Usually Inaccessible	1	Manage & Re-inspect
Store	0	0025 - Store	P027	No Access	Presumed Asbestos						12	No Access - Inspection Required
Store	External	0026 - Exterior Perimeter & Roof	S030	Pipework	Reinforced composites	Good Condition	Composite, reinforced or bonded	Chrysotile	Unknown	Easily Disturbed	2	Manage & Re-inspect
Toilet Block	0	0022 - Toilet	S024	Damp Proof Course	Bitumen Products	Good Condition	Composite, reinforced or bonded	Chrysotile	Unknown	Usually Inaccessible	2	Manage & Re-inspect

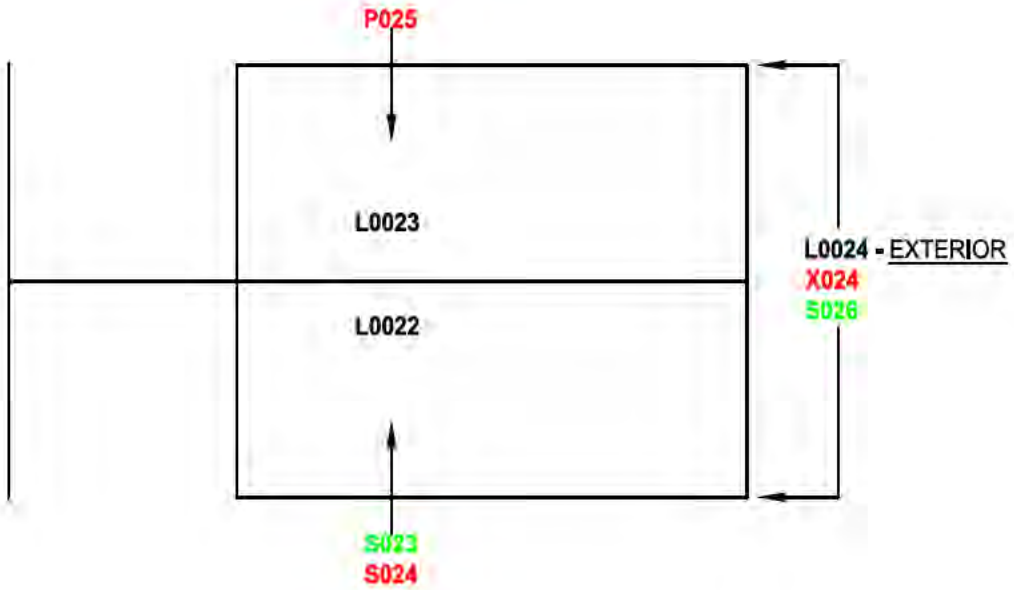
Building	Floor	Location / Room	Sample No	Position	Product Type	Damage	Surface Treatment	Asbestos Type	Estimated Amount	Access	Score	Recommendations
Toilet Block	0	0023 - Toilet	P025	No Access	Presumed Asbestos						12	No Access - Inspection Required
Toilet Block	External	0024 - Exterior Perimeter & Roof	X024	Damp Proof Course	Bitumen Products	Good Condition	Composite, reinforced or bonded	Chrysotile	Unknown	Usually Inaccessible	2	Manage & Re-inspect
