Asbestos Management Survey

Northleigh Road Allotments, B8 2QW

Report No	D-07902	**Report Issue Date**	22 August 2022
Client Name & Address	Property Services Inclusive Growth Directorate 10 Woodcock Street Birmingham B7 4BG	**Site Address**	Northleigh Road Allotments, Northleigh Road, Birmingham, B8 2QW
Order Placed By	[redacted]	**Instruction Date**	9 March 2022
Order Number	[redacted]	**Project Reference**	[redacted]
Survey Date(s)	28 March 2022	**Lead Surveyor**	[redacted]

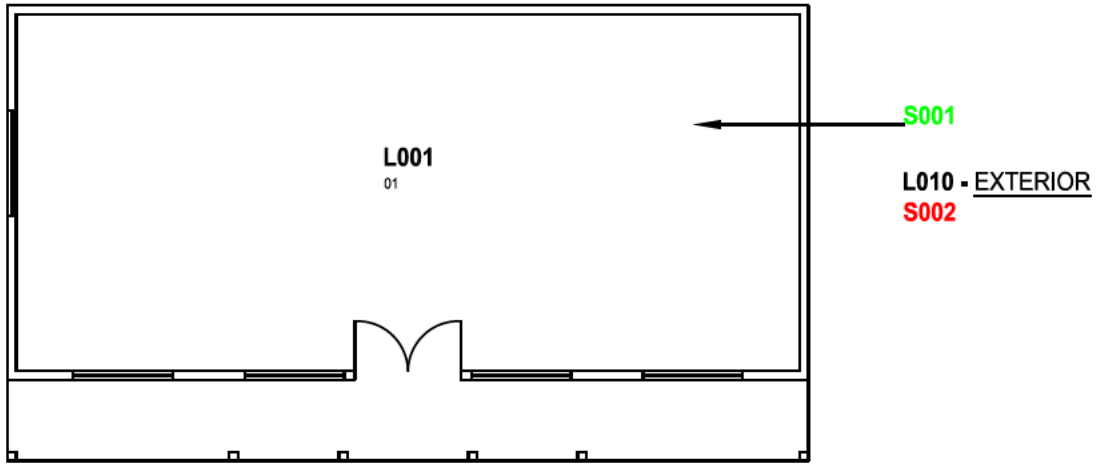
BLOCK A

Description Damp Proof Course.

Score
Asbestos Type	CHRYSOTILE	1
Product Type	Felt	1
Extent of Damage	Good Condition	0
Surface Treatment	Composite, reinforced or bonded	0
Estimated Amount	20 L/M	
Accessibility	Usually Inaccessible	
Risk Score		2

Recommendation	Manage & Re-inspect
Notes

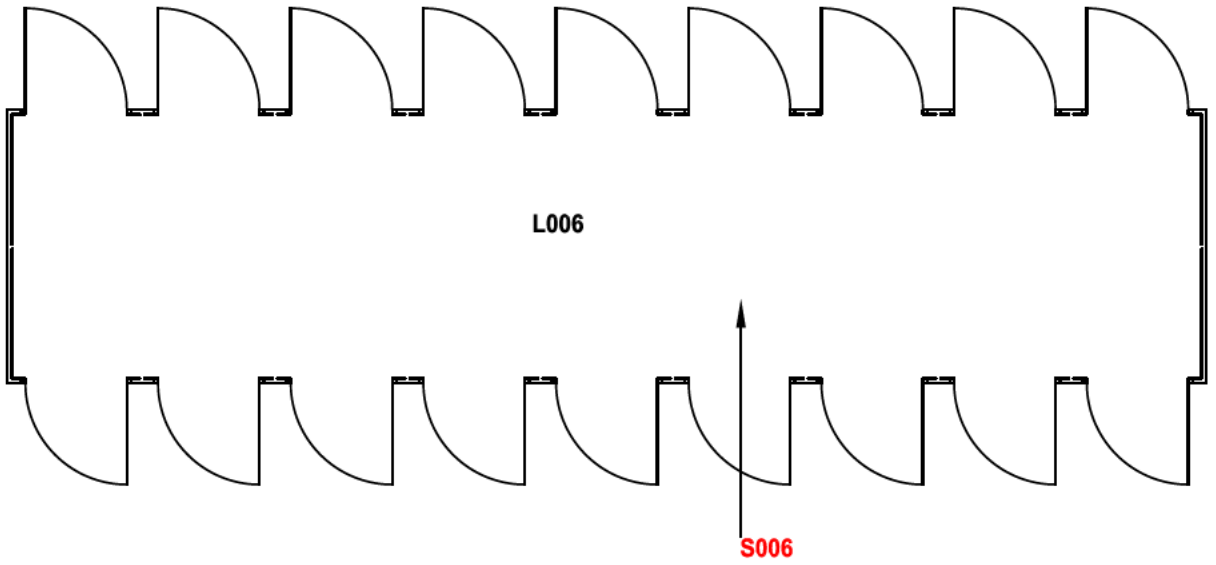
BLOCK C

Description Roof.

Score
Asbestos Type	CHRYSOTILE	1
Product Type	Cement Panels	1
Extent of Damage	Medium Damage	2
Surface Treatment	Unsealed cement / Enclosed lagging or spray / Encapsulated board	1
Estimated Amount	50 m²	
Accessibility	Easily Disturbed	
Risk Score		5

Recommendation	Encapsulate, Repair and Manage
Notes

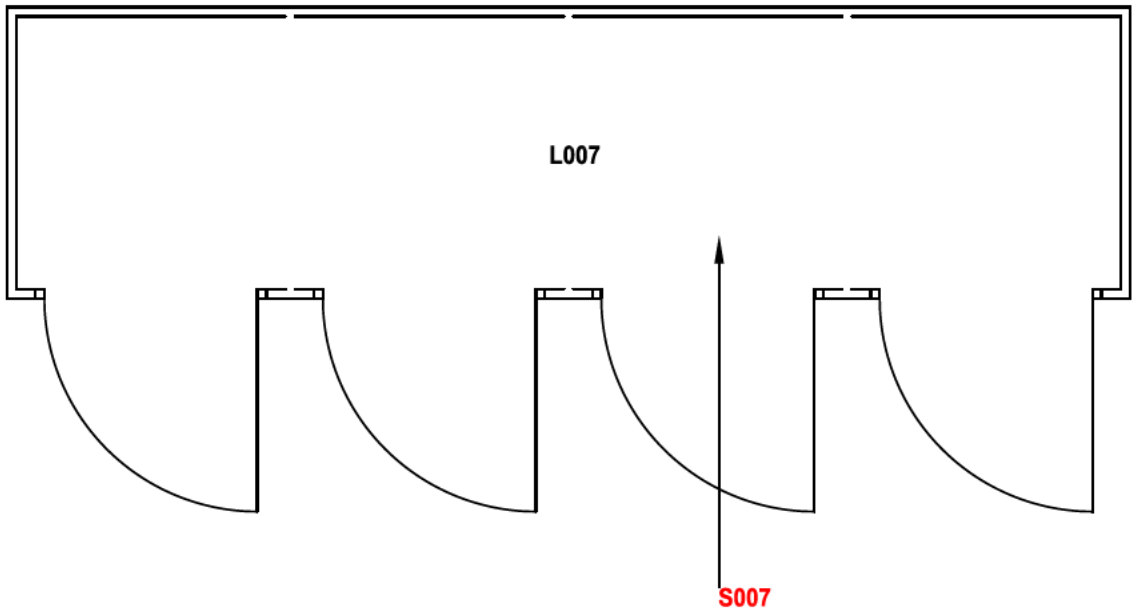
BLOCK D

Description Roof.

Score
Asbestos Type	CHRYSOTILE	1
Product Type	Cement Panels	1
Extent of Damage	Medium Damage	2
Surface Treatment	Unsealed cement / Enclosed lagging or spray / Encapsulated board	1
Estimated Amount	5 m²	
Accessibility	Occasional Disturbance	
Risk Score		5

Recommendation	Encapsulate, Repair and Manage
Notes	Lockers 21 & 22 removed.

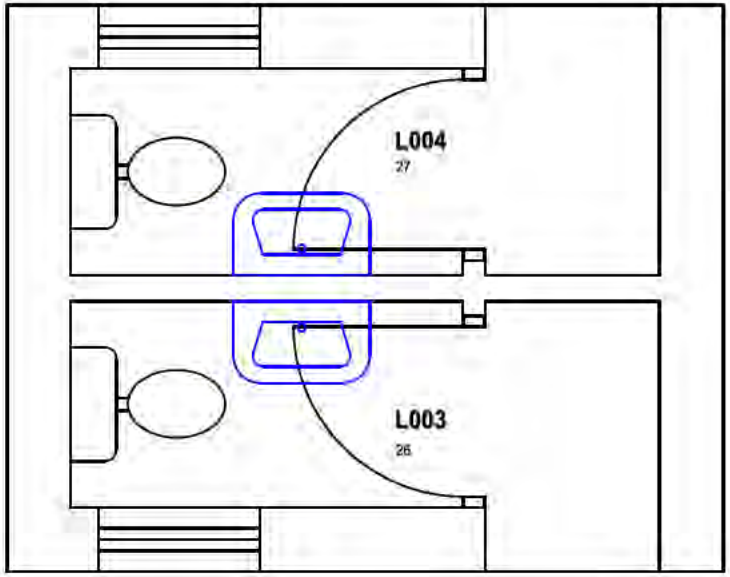
BLOCK F

Score
Asbestos Type	CHRYSOTILE	1
Product Type	Bitumen Products	1
Extent of Damage	Good Condition	0
Surface Treatment	Composite, reinforced or bonded	0
Estimated Amount	10 L/M	
Accessibility	Usually Inaccessible	
Risk Score		2

L005 - EXTERIOR
S004
S005

Recommendation	Manage & Re-inspect
Notes
