Asbestos Management Survey

Shenley Lane Allotments, B29 5PG

Report No	D-07905	**Report Issue Date**	22 February 2023
Client Name & Address	Property Services Place, Prosperity & Sustainability 10 Woodcock Street Birmingham B7 4BG	**Site Address**	Shenley Lane Allotments, Shenley Lane, Bartley Green, Birmingham, B29 5PG
Order Placed By	[redacted]	**Instruction Date**	9 March 2022
Order Number	[redacted]	**Project Reference**	[redacted]
Survey Date(s)	on 08/04/2022	**Lead Surveyor**	[redacted]

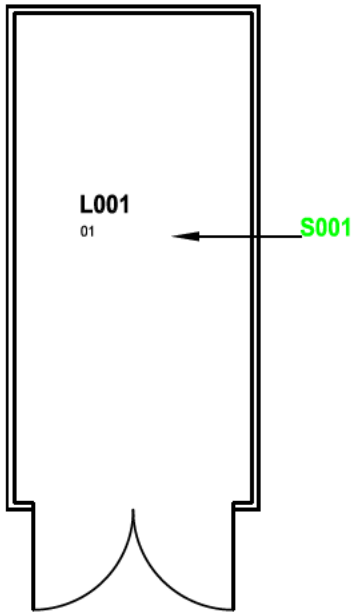
BLOCK A

Surveyor	[redacted]		**Building**	Block A
Survey Type	Management		**Floor**	0
Survey Date	08/04/2022		**Location/ Room**	001 - Shed 01
Next Inspection	08/04/2023		**Sample No**	S001
Level of Identification	Sample Analysed		**Inspection Ref**	724450

Description Walls .

Score
Asbestos Type	NO ASBESTOS DETECTED	-
Product Type	Putty	-
Extent of Damage	Low Damage	-
Surface Treatment	Composite, reinforced or bonded	-
Estimated Amount	30 L/M	
Accessibility	Occasional Disturbance	
Risk Score		0

Recommendation	No Recommendation Required
Notes

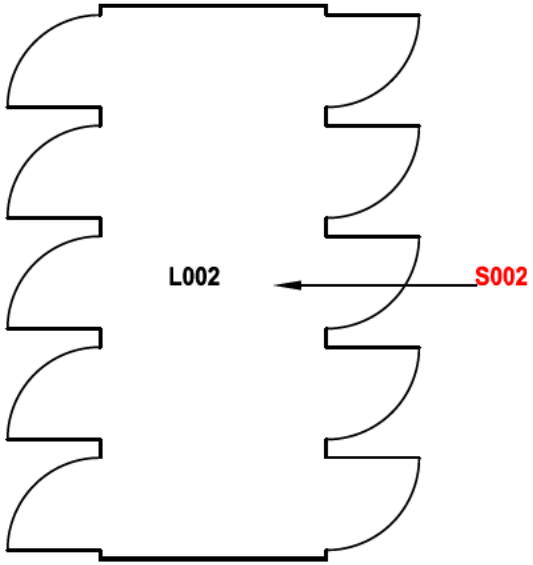
BLOCK B

Surveyor	[redacted]	**Building**	Block B
Survey Type	Management	**Floor**	0
Survey Date	08/04/2022	**Location/ Room**	002 - Tool lockers 02-11
Next Inspection	08/04/2023	**Sample No**	S002
Level of Identification	Sample Analysed	**Inspection Ref**	724472

Description Roof.

Score
Asbestos Type	CHRYSOTILE	1
Product Type	Cement Panels	1
Extent of Damage	Low Damage	1
Surface Treatment	Unsealed cement / Enclosed lagging or spray / Encapsulated board	1
Estimated Amount	20 m²	
Accessibility	Occasional Disturbance	
Risk Score		4

Recommendation	Manage & Re-inspect
Notes

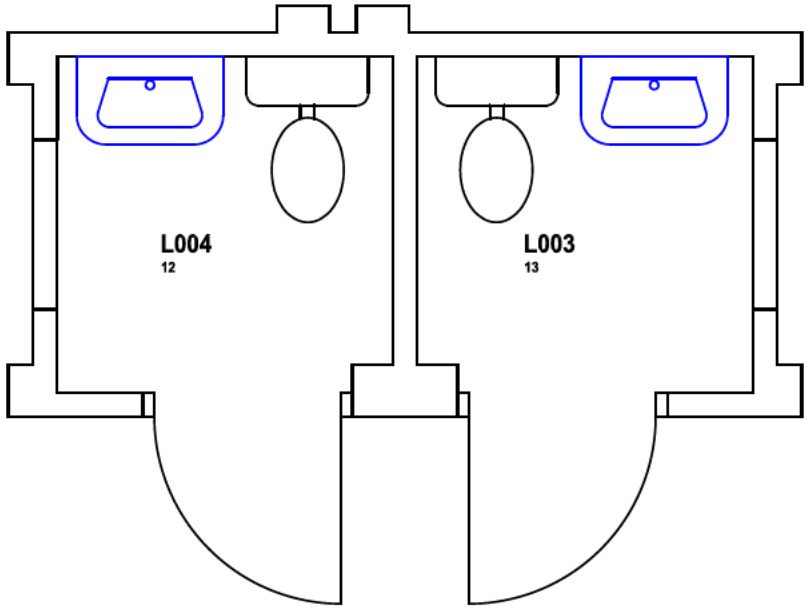
BLOCK C

Surveyor	[redacted]	**Building**	Block C
Survey Type	Management	**Floor**	External
Survey Date	08/04/2022	**Location/ Room**	005 - Exterior
Next Inspection	08/04/2023	**Sample No**	S003
Level of Identification	Sample Analysed	**Inspection Ref**	724465

Description Roof.

Score
Asbestos Type	NO ASBESTOS DETECTED	-
Product Type	Felt	-
Extent of Damage	Good Condition	-
Surface Treatment	Composite, reinforced or bonded	-
Estimated Amount	12 m²	
Accessibility	Usually Inaccessible	
Risk Score		0

Surveyor	[redacted]	**Building**	Block C
Survey Type	Management	**Floor**	External
Survey Date	08/04/2022	**Location/ Room**	005 - Exterior
Next Inspection	08/04/2023	**Sample No**	S004
Level of Identification	Sample Analysed	**Inspection Ref**	724469

Description Roof Soffit.

Score
Asbestos Type	NO ASBESTOS DETECTED	-
Product Type	Board	-
Extent of Damage	Good Condition	-
Surface Treatment	Unsealed cement / Enclosed lagging or spray / Encapsulated board	-
Estimated Amount	8 L/M	
Accessibility	Usually Inaccessible	
Risk Score		0

Surveyor	[redacted]	**Building**	Block C
Survey Type	Management	**Floor**	External
Survey Date	08/04/2022	**Location/ Room**	005 - Exterior
Next Inspection	08/04/2023	**Sample No**	S005
Level of Identification	Sample Analysed	**Inspection Ref**	724471

Description Door frames .

Score
Asbestos Type	NO ASBESTOS DETECTED	-
Product Type	Putty	-
Extent of Damage	Good Condition	-
Surface Treatment	Composite, reinforced or bonded	-
Estimated Amount	4 L/M	
Accessibility	Usually Inaccessible	
Risk Score		0
