Asbestos Management Survey

Woodthorpe Road Allotments, B14 6EQ

Report No	D-07910	**Report Issue Date**	24 June 2022
Client Name & Address	Property Services Inclusive Growth Directorate 10 Woodcock Street Birmingham B7 4BG	**Site Address**	Woodthorpe Road Allotments, Woodthorpe Road, Birmingham, B14 6EQ
Order Placed By	[redacted]	**Instruction Date**	9 March 2022
Order Number	[redacted]	**Project Reference**	[redacted]
Survey Date(s)	18 March 2022	**Lead Surveyor**	[redacted]

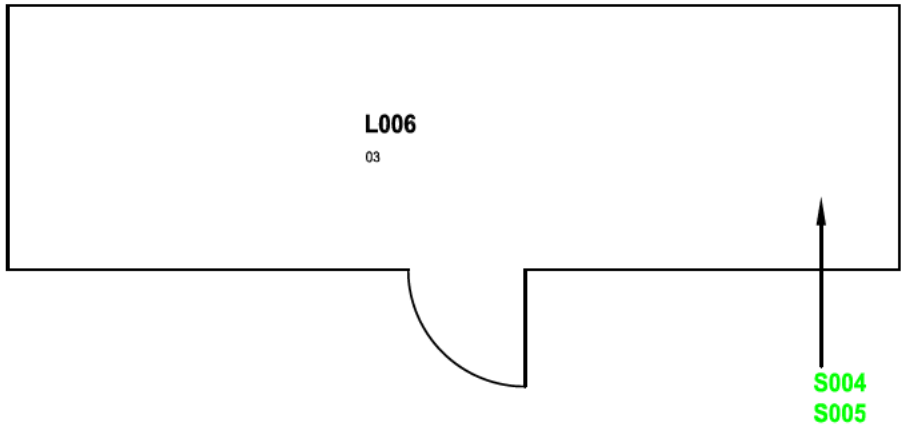
Job No: D - 07910
Drawing No: D - 07910 - 1

CLUB HOUSE

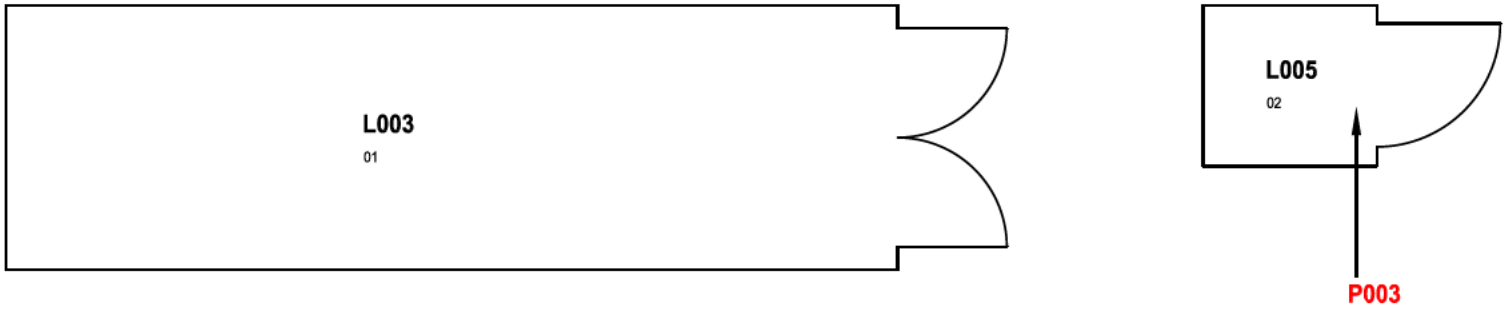
Job No: D - 07910
Drawing No: D - 07910 - 2

STEEL UNIT
