Asbestos Management Survey

Longmeadow Crescent Allotments - Toilet PAL02127-A-01, B34 7NP

Report No	D-08151	**Report Issue Date**	10 March 2023
Client Name & Address	Property Services Place, Prosperity & Sustainability 10 Woodcock Street Birmingham B7 4BG	**Site Address**	Longmeadow Crescent Allotments - Toilet PAL02127-A-01, Longmeadow Crescent, Birmingham, B34 7NP
Order Placed By	[redacted]	**Instruction Date**	26 May 2022
Order Number	[redacted]	**Project Reference**	[redacted]
Survey Date(s)	on 21/07/2022	**Lead Surveyor**	[redacted]

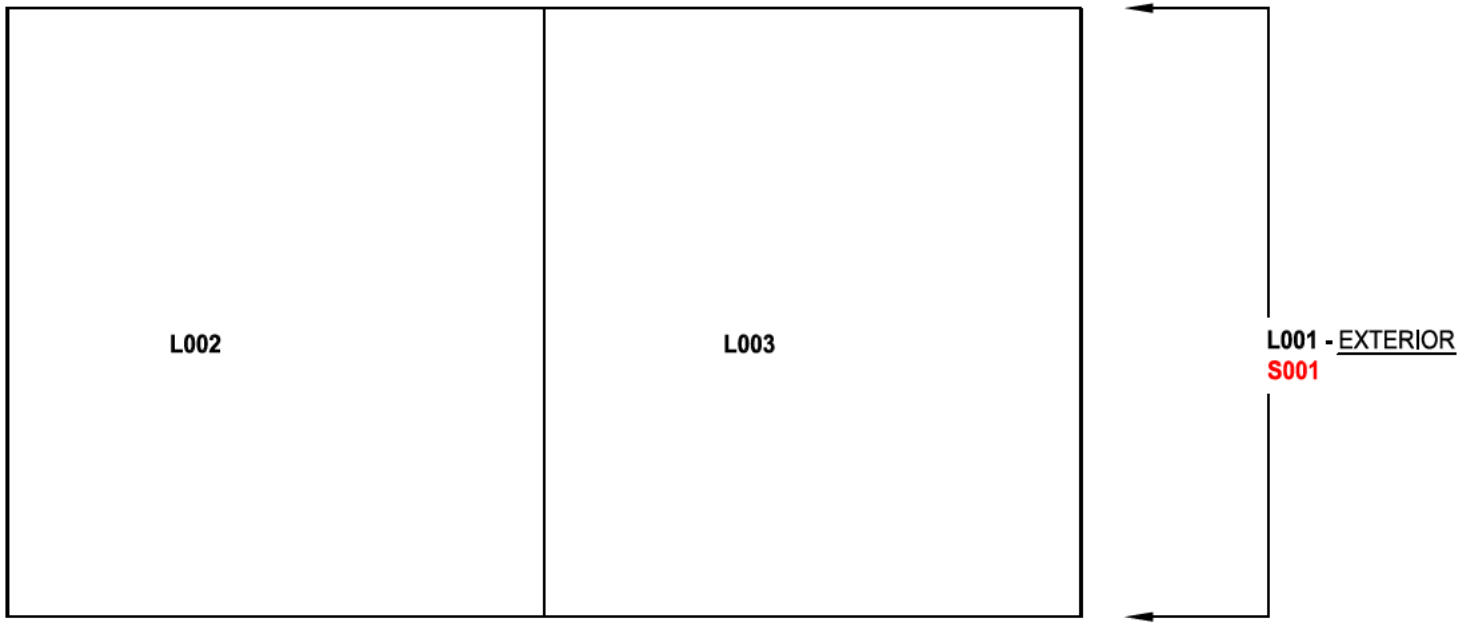
Job No: D - 08151
Drawing No: D - 08151 - 1

Floor Level : Ground and EXTERIOR
