Asbestos Management Survey

The Boulevard Allotments, B73 5JB

Report No	D-09842	**Report Issue Date**	20 December 2023
Client Name & Address	Property Services Place, Prosperity & Sustainability 10 Woodcock Street Birmingham B7 4BG	**Site Address**	The Boulevard Allotments, The Boulevard, Sutton New Hall, Sutton Coldfield, B73 5JB
Order Placed By	[redacted]	**Instruction Date**	15 August 2023
Order Number	[redacted]	**Project Reference**	[redacted]
Survey Date(s)	on 21/08/2023	**Lead Surveyor**	[redacted]

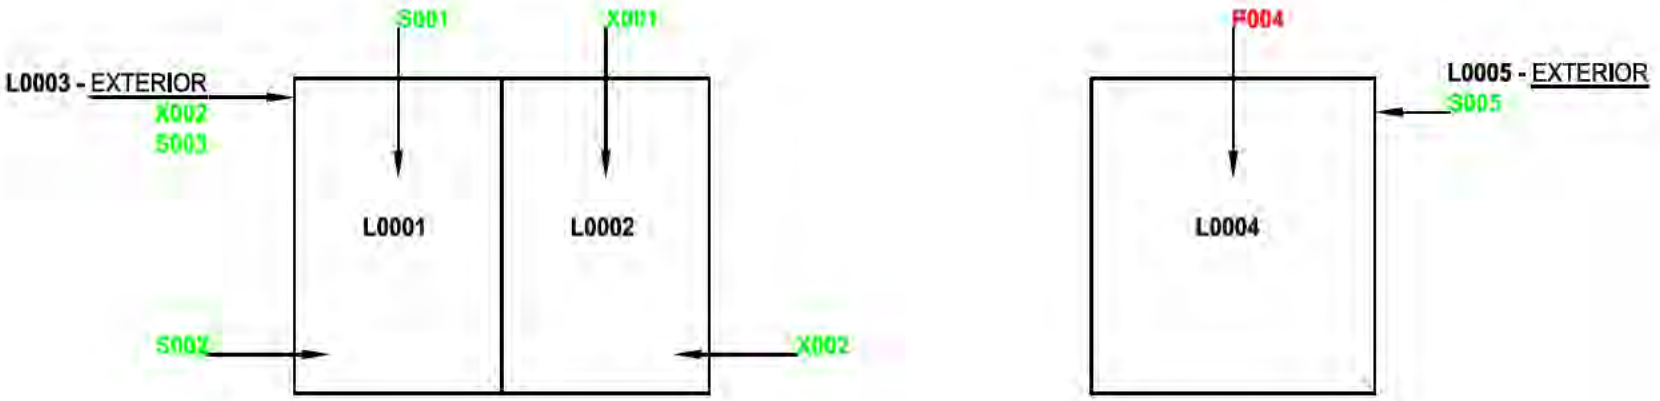
Job No: D - 09842
Drawing No: D - 09842 - 1

Building	Location / Room	Description	Notes
Store	Floor - 0 0004 - Store	No Access .	Presumed due to no access. No key available at time of survey.
