Asbestos Management Survey

Clay Lane Allotment, B26 1ED

Report No	D-09843	**Report Issue Date**	26 September 2023
Client Name & Address	Property Services Place, Prosperity & Sustainability 10 Woodcock Street Birmingham B7 4BG	**Site Address**	Clay Lane Allotment, Clay Lane, Birmingham, B26 1ED
Order Placed By	[redacted]	**Instruction Date**	15 August 2023
Order Number	[redacted]	**Project Reference**	[redacted]
Survey Date(s)	on 17/08/2023	**Lead Surveyor**	[redacted]

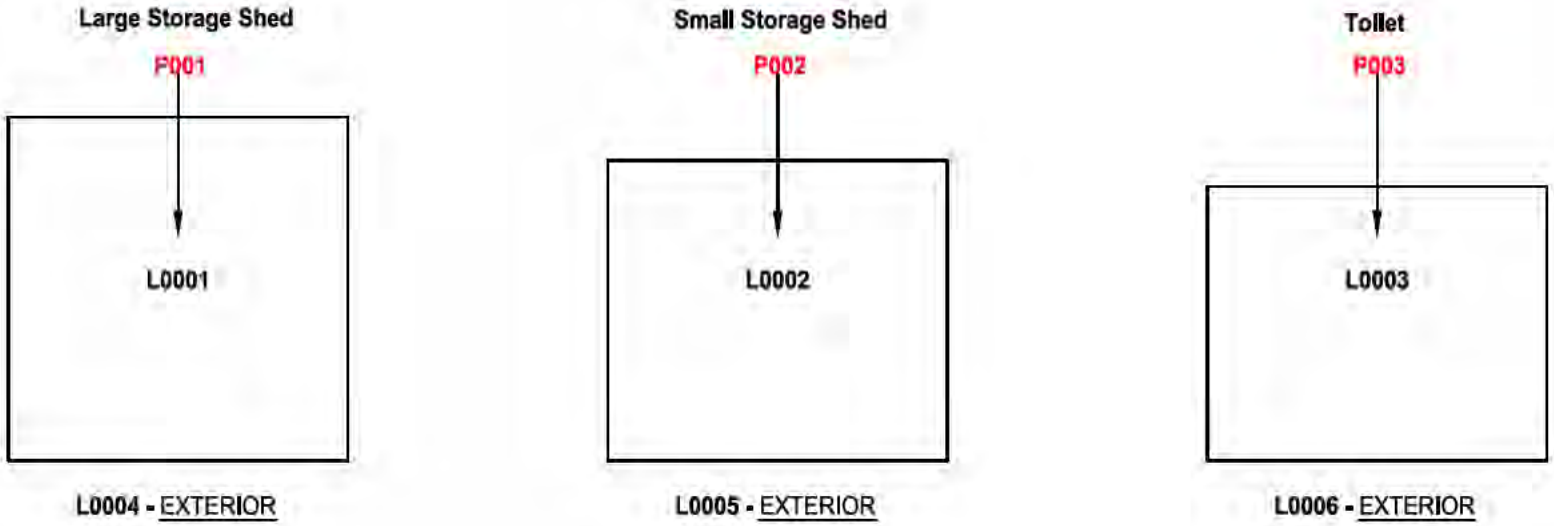
Job No: D - 09843
Drawing No: D - 09843 - 1

L0004 - EXTERIOR

L0005 - EXTERIOR

L0006 - EXTERIOR
