Asbestos
Reinspection Report

Henlow Road Allotments, B14 5DX

Report No	R-00169	**Report Issue Date**	11 May 2023
Client Name & Address	Property Services Place, Prosperity & Sustainability 10 Woodcock Street Birmingham B7 4BG	**Site Address**	Henlow Road Allotments, Henlow Road, Birmingham, B14 5DX
Order Placed By	[redacted]	**Instruction Date**	27 February 2023
Order Number	[redacted]	**Project Reference**	[redacted]
Reinspection Report Date	22/03/2024	**Lead Surveyor**	[redacted]

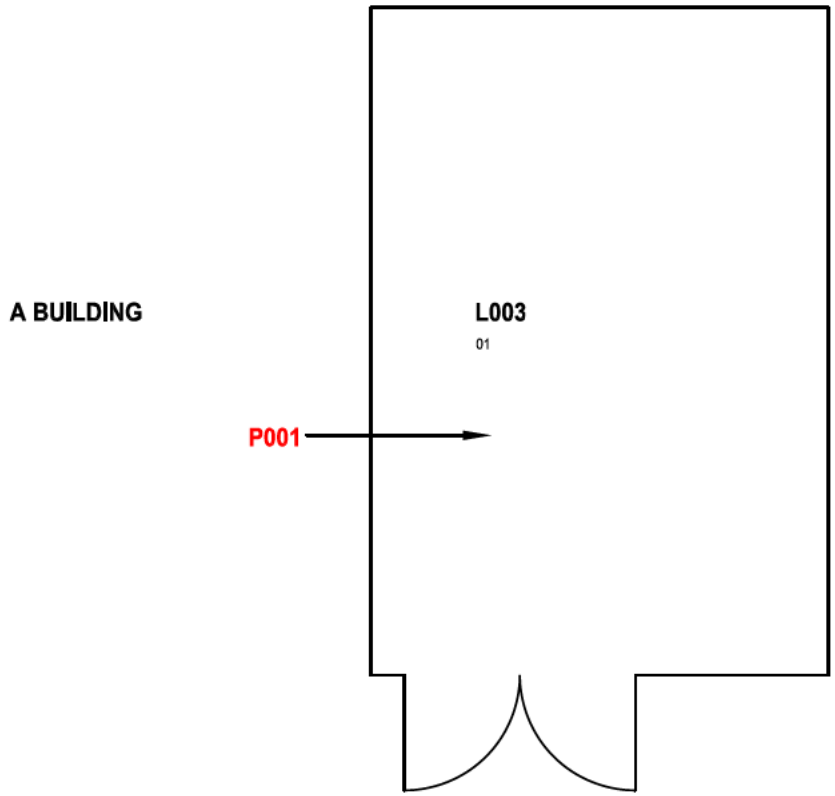
Job No: R - 00169
Drawing No: R - 00169 - 1

Building	Floor	Location No and Name	Item	Further Information	Material Assessment (default)
A Building	0	003 Shed 01	Electrical Switchgear	Presumed due to live electrics. No change.	Presumed Asbestos
