Asbestos
Reinspection Report

Harborne Hill Allotments, B15 3JN

Report No	R-00170	**Report Issue Date**	28 June 2023
Client Name & Address	Property Services Place, Prosperity & Sustainability 10 Woodcock Street Birmingham B7 4BG	**Site Address**	Harborne Hill Allotments, Harborne Road, Birmingham, B15 3JN
Order Placed By	[redacted]	**Instruction Date**	27 February 2023
Order Number	[redacted]	**Project Reference**	[redacted]
Reinspection Report Date	18/04/2024	**Lead Surveyor**	[redacted]

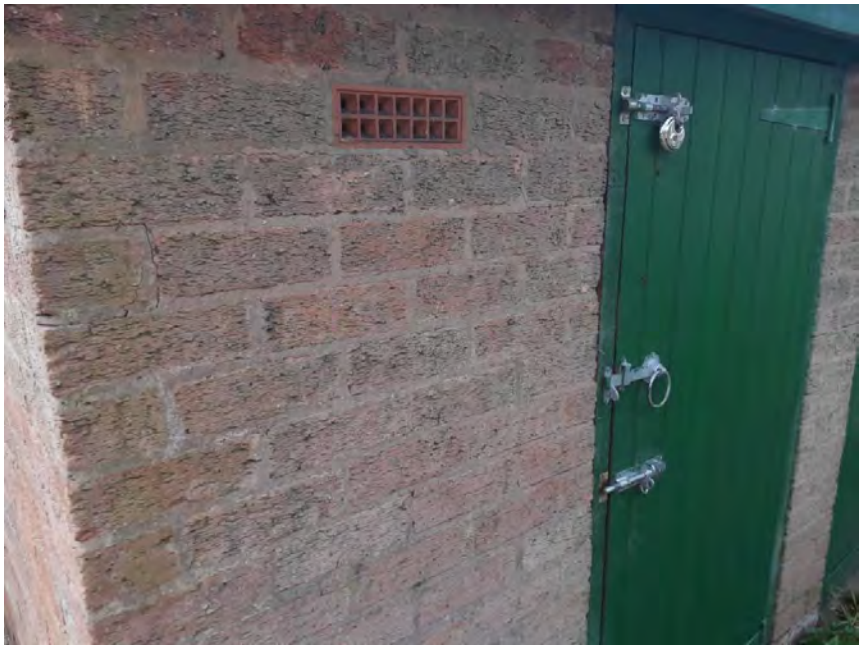
Surveyor	[redacted]		**Building**	Block B
Survey Type	Re-Inspection		**Floor**	0
Survey Date	18/04/2023		**Location/ Room**	004 - Tool lockers 04
Next Inspection	18/04/2024		**Sample No**	P008
Level of Identification	Presumed		**Inspection Ref**	828912

Description Tool lockers 04.

Score
Asbestos Type	Presumed Asbestos	-
Product Type		-
Extent of Damage		-
Surface Treatment		-
Estimated Amount		
Accessibility		
Risk Score		12

Recommendation	Inspection Required
Notes	Access to the room could not be gained key's not available.

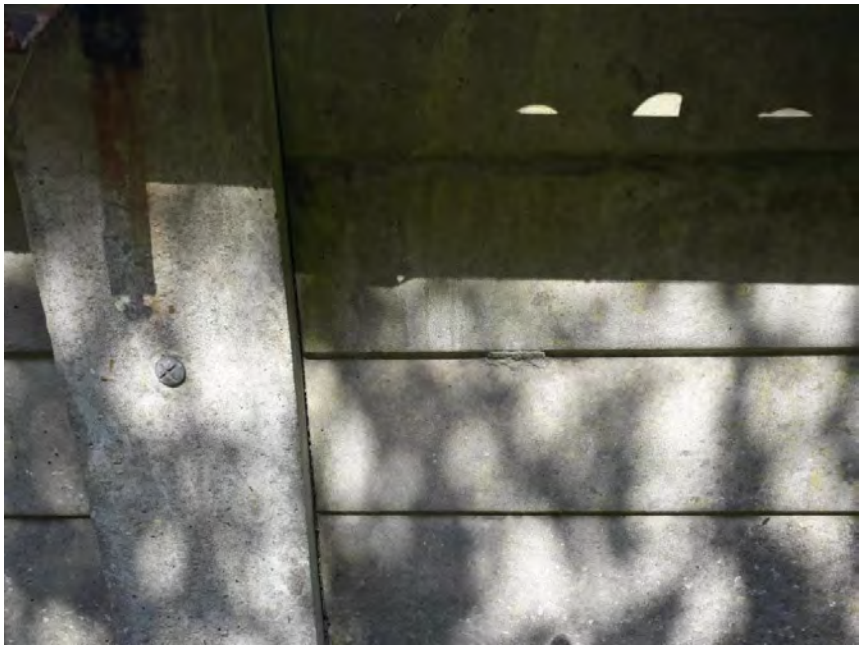
Surveyor	[redacted]	**Building**	Block G
Survey Type	Re-Inspection	**Floor**	0
Survey Date	18/04/2023	**Location/ Room**	011 - Tool lockers
Next Inspection	18/04/2024	**Sample No**	PS013
Level of Identification	Previously Sampled	**Inspection Ref**	828909

Description Walls.

Older putty/mastic.

Score
Asbestos Type	CHRYSOTILE	1
Product Type	Putty	1
Extent of Damage	Good Condition	0
Surface Treatment	Composite, reinforced or bonded	0
Estimated Amount	20 L/M	
Accessibility	Usually Inaccessible	
Risk Score		2

Recommendation	Manage & Re-inspect
Notes	No change
