Asbestos
Reinspection Report

Manor House Lane Leisure Gardens Allotment, B26 1PP

Report No	R-00171	**Report Issue Date**	10 May 2023
Client Name & Address	Property Services Place, Prosperity & Sustainability 10 Woodcock Street Birmingham B7 4BG	**Site Address**	Manor House Lane Leisure Gardens Allotment, Manor House Lane, Birmingham, B26 1PP
Order Placed By	[redacted]	**Instruction Date**	27 February 2023
Order Number	[redacted]	**Project Reference**	[redacted]
Reinspection Report Date	15/03/2024	**Lead Surveyor**	[redacted]

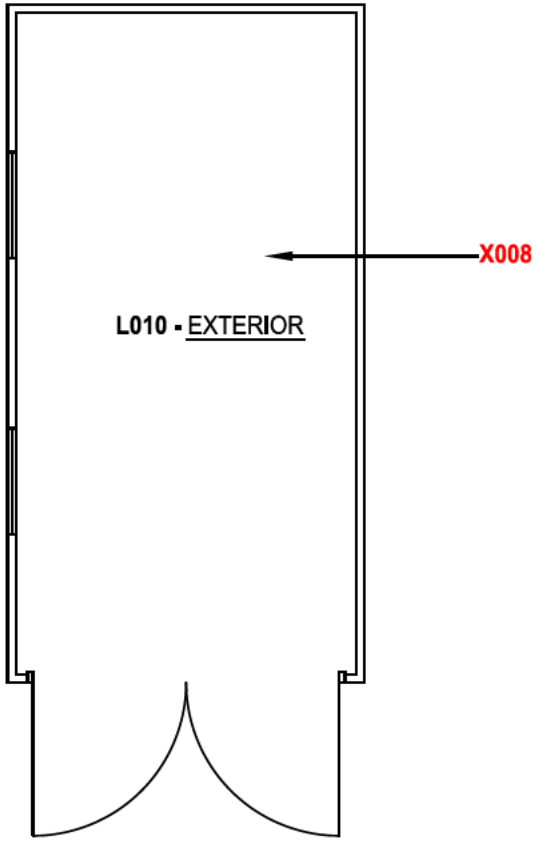
STORE

Building	Floor	Location No and Name	Item	Material	Level of Identification	Risk Assessment
Store	0	009 Store 06	Ceiling	Cement Products	PS008	Very Low
Store	99	010 Exterior Perimeter	Roof	Cement Products	X008	Very Low

Building	Floor	Location / Room	Sample No	Position	Product Type	Damage	Surface Treatment	Asbestos Type	Estimated Amount	Access	Score	Recommendations
Store	0	009 - Store 06	PS008	Ceiling	Cement Products	Good Condition	Composite, reinforced or bonded	Chrysotile	12 m²	Occasional Disturbance	2	Manage & Re-inspect
Store	External	010 - Exterior Perimeter	X008	Roof	Cement Products	Good Condition	Unsealed cement / Enclosed lagging or spray / Encapsulated board	Chrysotile	12 m²	Occasional Disturbance	3	Manage & Re-inspect
Toilet Block	0	002 - Toilet 4	P003	Boxing	Presumed Asbestos						12	No Access - Inspection Required

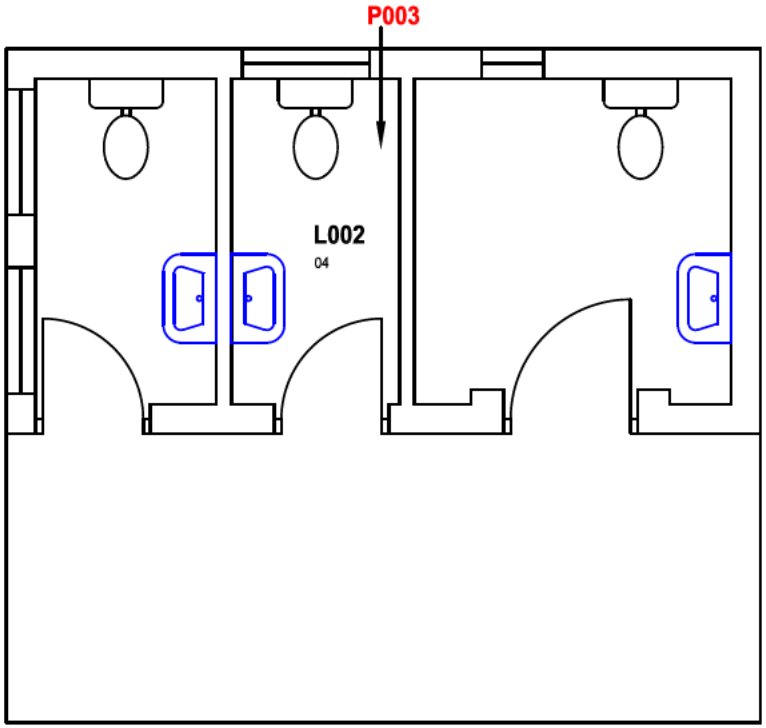
TOILET BLOCK

Building	Floor	Location No and Name	Item	Material	Level of Identification	Risk Assessment
Toilet Block	0	002 Toilet 4	Boxing	Presumed Asbestos	P003	12

Building	Floor	Location No and Name	Item	Further Information	Material Assessment (default)
Toilet Block	0	002 Toilet 4	Boxing	Presumed boxing due to access would cause irreparable damage.	Presumed Asbestos
