Asbestos
Reinspection Report

Quinton Leisure Gardens (Allotment), B32 1QS

Report No	R-00173	**Report Issue Date**	6 July 2023
Client Name & Address	Property Services Place, Prosperity & Sustainability 10 Woodcock Street Birmingham B7 4BG	**Site Address**	Quinton Leisure Gardens (Allotment), Stourton Road, Birmingham, B32 1QS
Order Placed By	[redacted]	**Instruction Date**	27 February 2023
Order Number	[redacted]	**Project Reference**	[redacted]
Reinspection Report Date	13/04/2024	**Lead Surveyor**	[redacted]

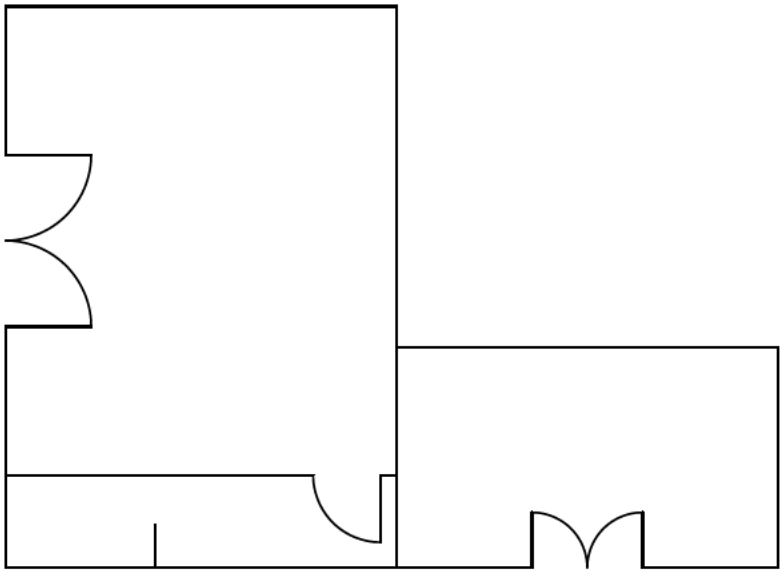
L003 - EXTERIOR
PS004
PS005

Description Roof Soffit.

Score
Asbestos Type	CHRYSOTILE	1
Product Type	Cement Panels	1
Extent of Damage	Good Condition	0
Surface Treatment	Composite, reinforced or bonded	0
Estimated Amount	30 L/M	
Accessibility	Usually Inaccessible	
Risk Score		2

Description Damp Proof Course.

Score
Asbestos Type	CHRYSOTILE	1
Product Type	Bitumen Products	1
Extent of Damage	Good Condition	0
Surface Treatment	Composite, reinforced or bonded	0
Estimated Amount	40 L/M	
Accessibility	Usually Inaccessible	
Risk Score		2

Recommendation	Manage & Re-inspect
Notes	No change

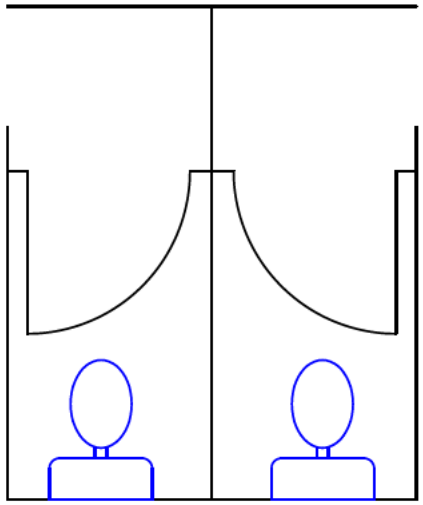
L008 - EXTERIOR
PS006

Description Damp Proof Course.

Score
Asbestos Type	CHRYSOTILE	1
Product Type	Bitumen Products	1
Extent of Damage	Good Condition	0
Surface Treatment	Composite, reinforced or bonded	0
Estimated Amount	10 L/M	
Accessibility	Usually Inaccessible	
Risk Score		2

Recommendation	Manage & Re-inspect
Notes	No change

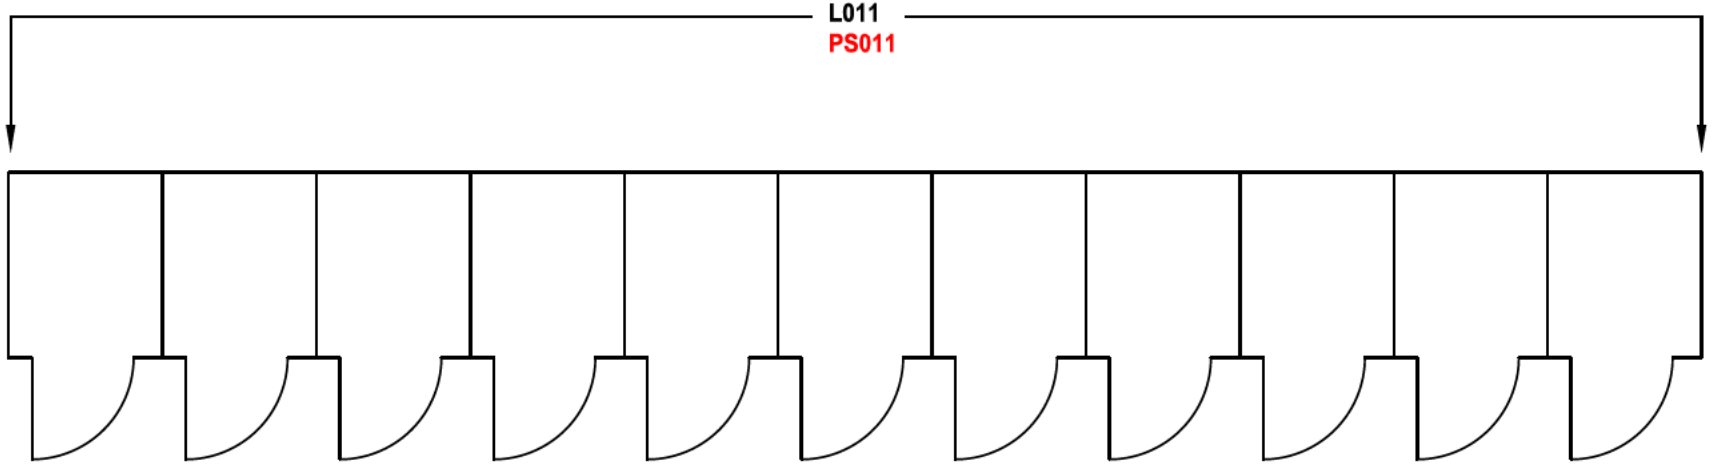
BLOCK D

Description Roof.

Score
Asbestos Type	CHRYSOTILE	1
Product Type	Cement Panels	1
Extent of Damage	Low Damage	1
Surface Treatment	Unsealed cement / Enclosed lagging or spray / Encapsulated board	1
Estimated Amount	30 m²	
Accessibility	Occasional Disturbance	
Risk Score		4

Recommendation	Encapsulate, Repair and Manage
Notes	Localised repairs recommended. No change Lockers renumbered 68 to 75

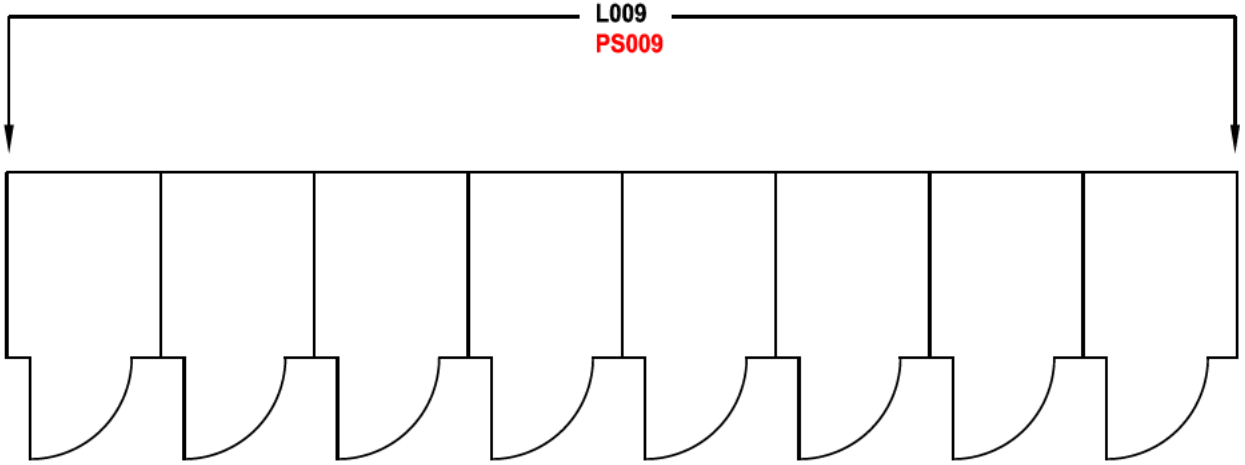
BLOCK F

Description Roof.

Score
Asbestos Type	CHRYSOTILE	1
Product Type	Cement Panels	1
Extent of Damage	Low Damage	1
Surface Treatment	Unsealed cement / Enclosed lagging or spray / Encapsulated board	1
Estimated Amount	20 m²	
Accessibility	Occasional Disturbance	
Risk Score		4

Recommendation	Manage & Re-inspect
Notes	No change Lockers renumbered 50 to 64

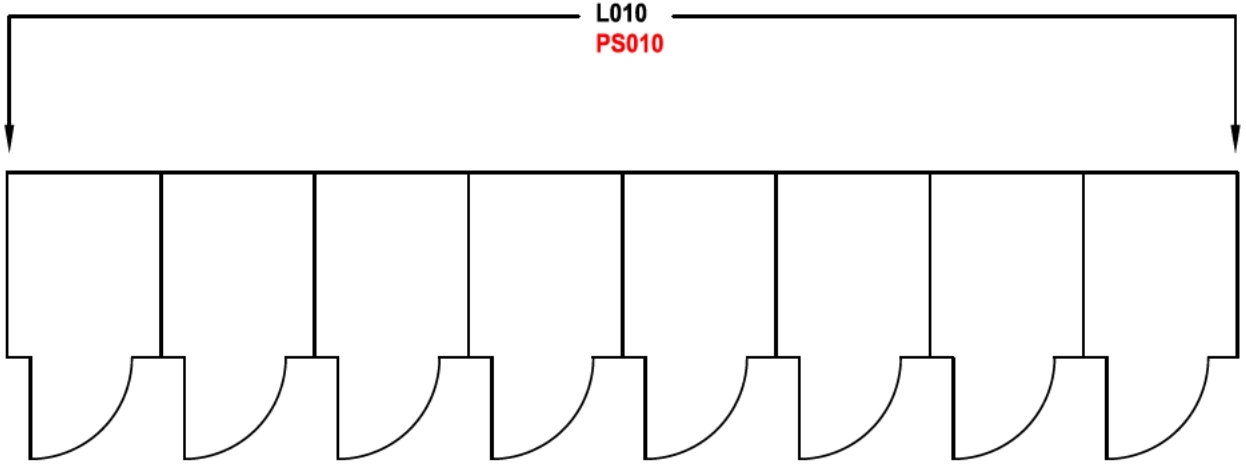
BLOCK G

Description Roof.

Score
Asbestos Type	CHRYSOTILE	1
Product Type	Cement Panels	1
Extent of Damage	Low Damage	1
Surface Treatment	Unsealed cement / Enclosed lagging or spray / Encapsulated board	1
Estimated Amount	20 m²	
Accessibility	Occasional Disturbance	
Risk Score		4

Recommendation	Manage & Re-inspect
Notes	Damaged areas have been painted. Lockers 28 to 38

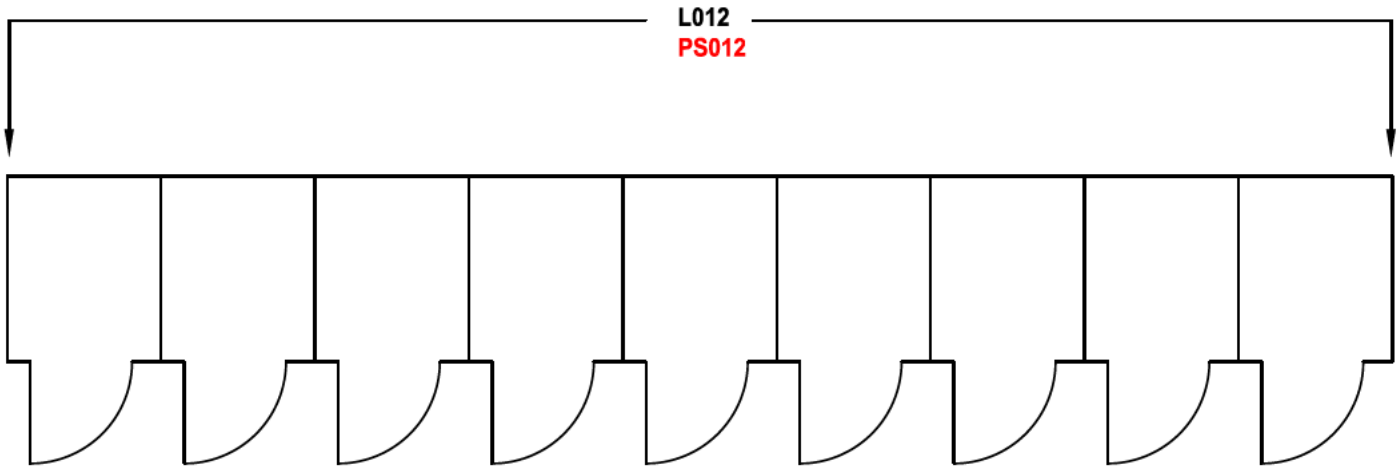
BLOCK H

Description Roof.

Score
Asbestos Type	CHRYSOTILE	1
Product Type	Cement Panels	1
Extent of Damage	Medium Damage	2
Surface Treatment	Unsealed cement / Enclosed lagging or spray / Encapsulated board	1
Estimated Amount	25 m²	
Accessibility	Occasional Disturbance	
Risk Score		5

Recommendation	Encapsulate, Repair and Manage
Notes	Localised repairs recommended. No change Lockers 76 to 84
