Asbestos
Reinspection Report

Hawthorn House Allotments, B20 1NR

Report No	R-00193	**Report Issue Date**	28 July 2023
Client Name & Address	Property Services Place, Prosperity & Sustainability 10 Woodcock Street Birmingham B7 4BG	**Site Address**	Hawthorn House Allotments, Pavilion, Hamstead Hall Road, Birmingham, B20 1NR
Order Placed By	[redacted]	**Instruction Date**	8 March 2023
Order Number	[redacted]	**Project Reference**	[redacted]
Reinspection Report Date	06/07/2024	**Lead Surveyor**	[redacted]

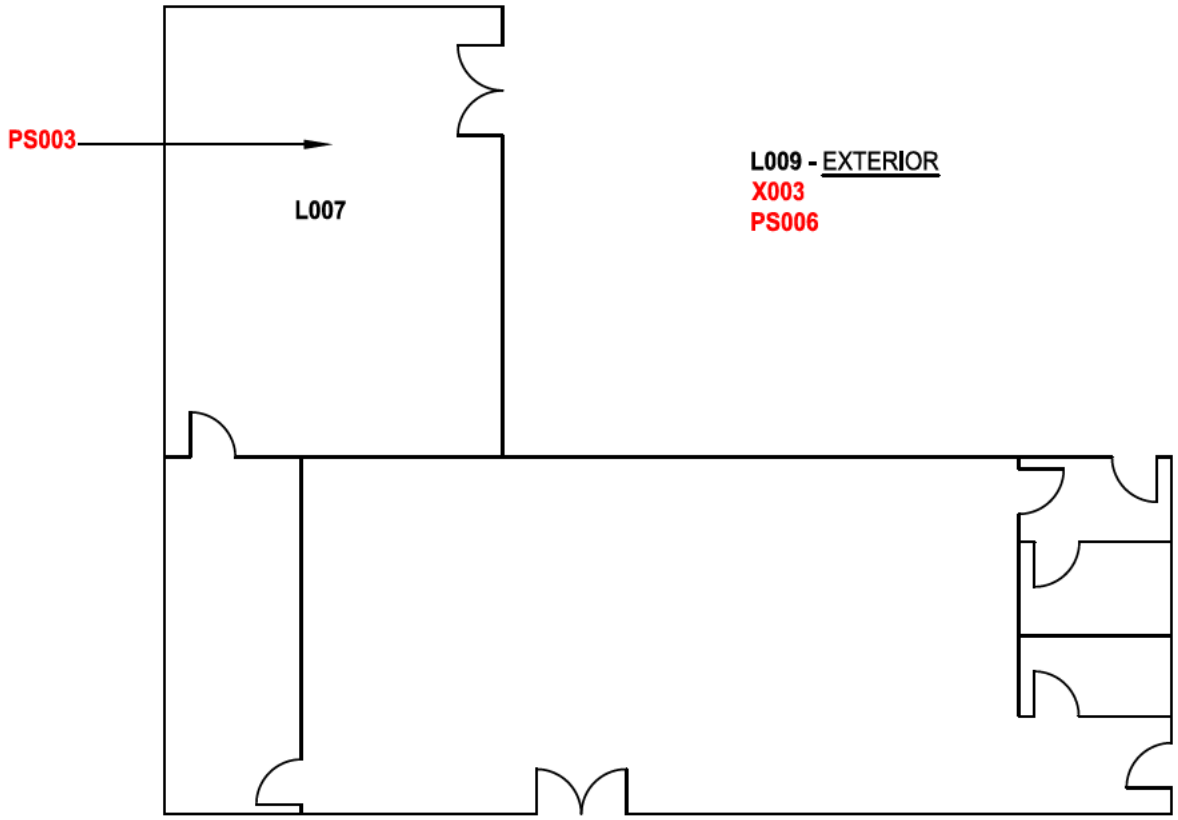
PAVILION

Description Roof Soffit.

Recommendation	Manage & Re-inspect
Notes	No change.

Description Roof Soffit. Visually consistent with Sample 3.

Score
Asbestos Type	CHRYSOTILE	1
Product Type	Cement Panels	1
Extent of Damage	Low Damage	1
Surface Treatment	Composite, reinforced or bonded	0
Estimated Amount	30 L/M	
Accessibility	Usually Inaccessible	
Risk Score		3

Recommendation	Manage & Re-inspect
Notes	Previous recommendation has been acted on.

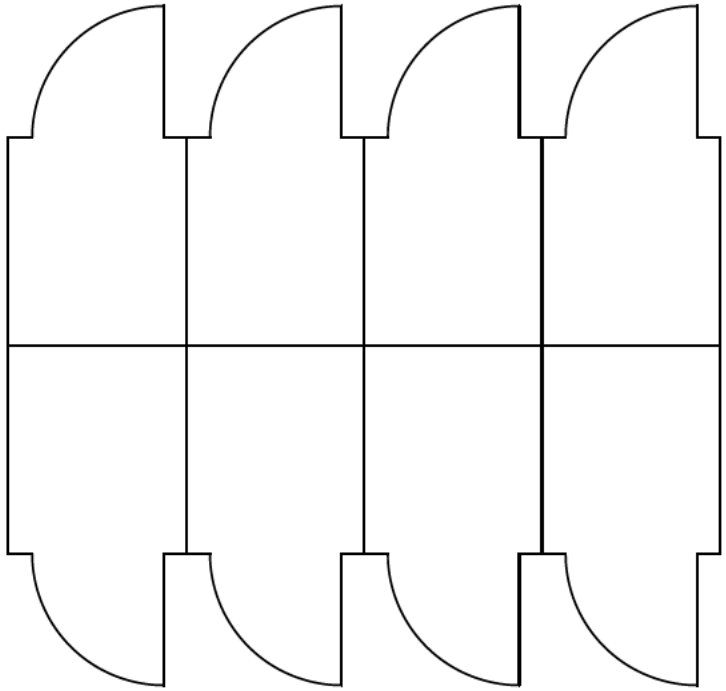
L013 - EXTERIOR
PS010

Description Roof.

Score
Asbestos Type	CHRYSOTILE	1
Product Type	Cement Panels	1
Extent of Damage	Low Damage	1
Surface Treatment	Unsealed cement / Enclosed lagging or spray / Encapsulated board	1
Estimated Amount	12 m²	
Accessibility	Occasional Disturbance	
Risk Score		4

Recommendation	Manage & Re-inspect
Notes	No change.

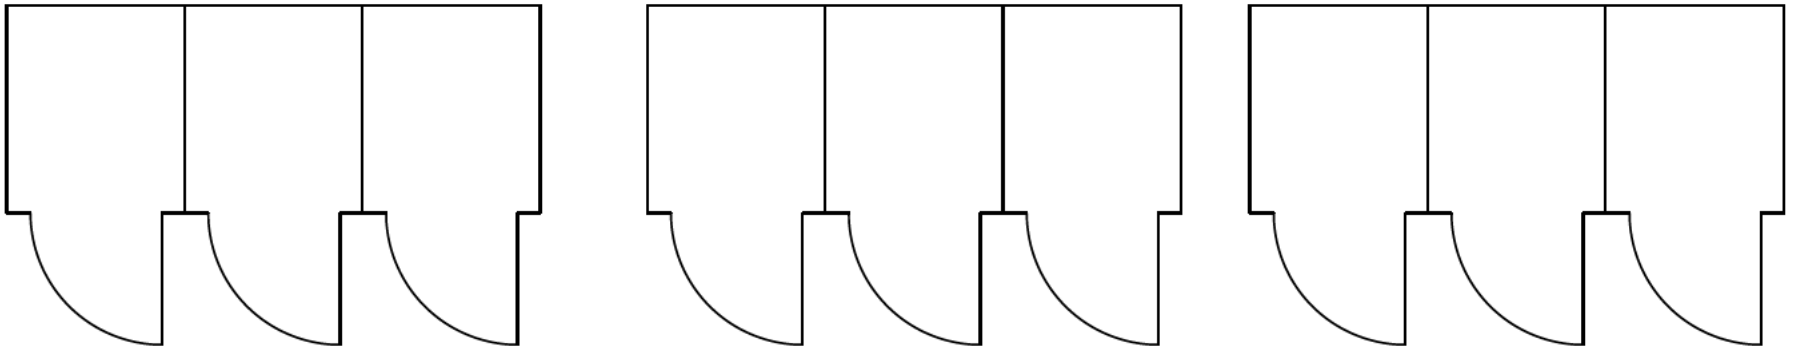
L010
PS009

Description Roof.

Score
Asbestos Type	CHRYSOTILE	1
Product Type	Cement Panels	1
Extent of Damage	Low Damage	1
Surface Treatment	Unsealed cement / Enclosed lagging or spray / Encapsulated board	1
Estimated Amount	4 m²	
Accessibility	Occasional Disturbance	
Risk Score		4

Description Roof. Visually consistent with Sample 9.

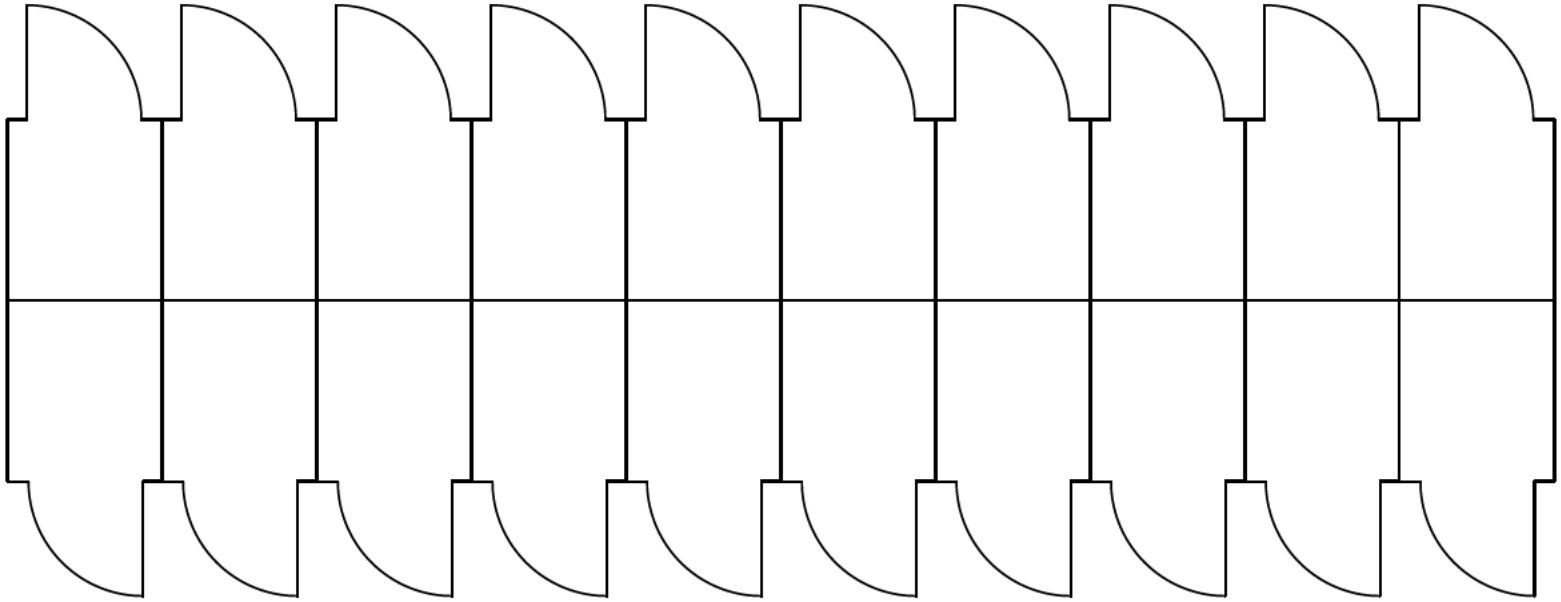
L008
PS008

Description Roof.

Score
Asbestos Type	CHRYSOTILE	1
Product Type	Cement Panels	1
Extent of Damage	Good Condition	0
Surface Treatment	Unsealed cement / Enclosed lagging or spray / Encapsulated board	1
Estimated Amount	25 m²	
Accessibility	Occasional Disturbance	
Risk Score		3

Recommendation	Manage & Re-inspect
Notes	No change.
